UPPER TOWNSHIP MUNICIPAL SHORELINE MONITORING

2022 ANNUAL REPORT (covering monitoring activities January 2022-December 2022)

**FINAL REPORT FOR 2022
ON THE CONDITION OF THE MUNICIPAL BEACHES
IN
THE TOWNSHIP OF UPPER, CAPE MAY COUNTY, NEW JERSEY**

**Annual Report for 2022
To
The Township of Upper
On the Condition of the Municipal Beaches in Strathmere**

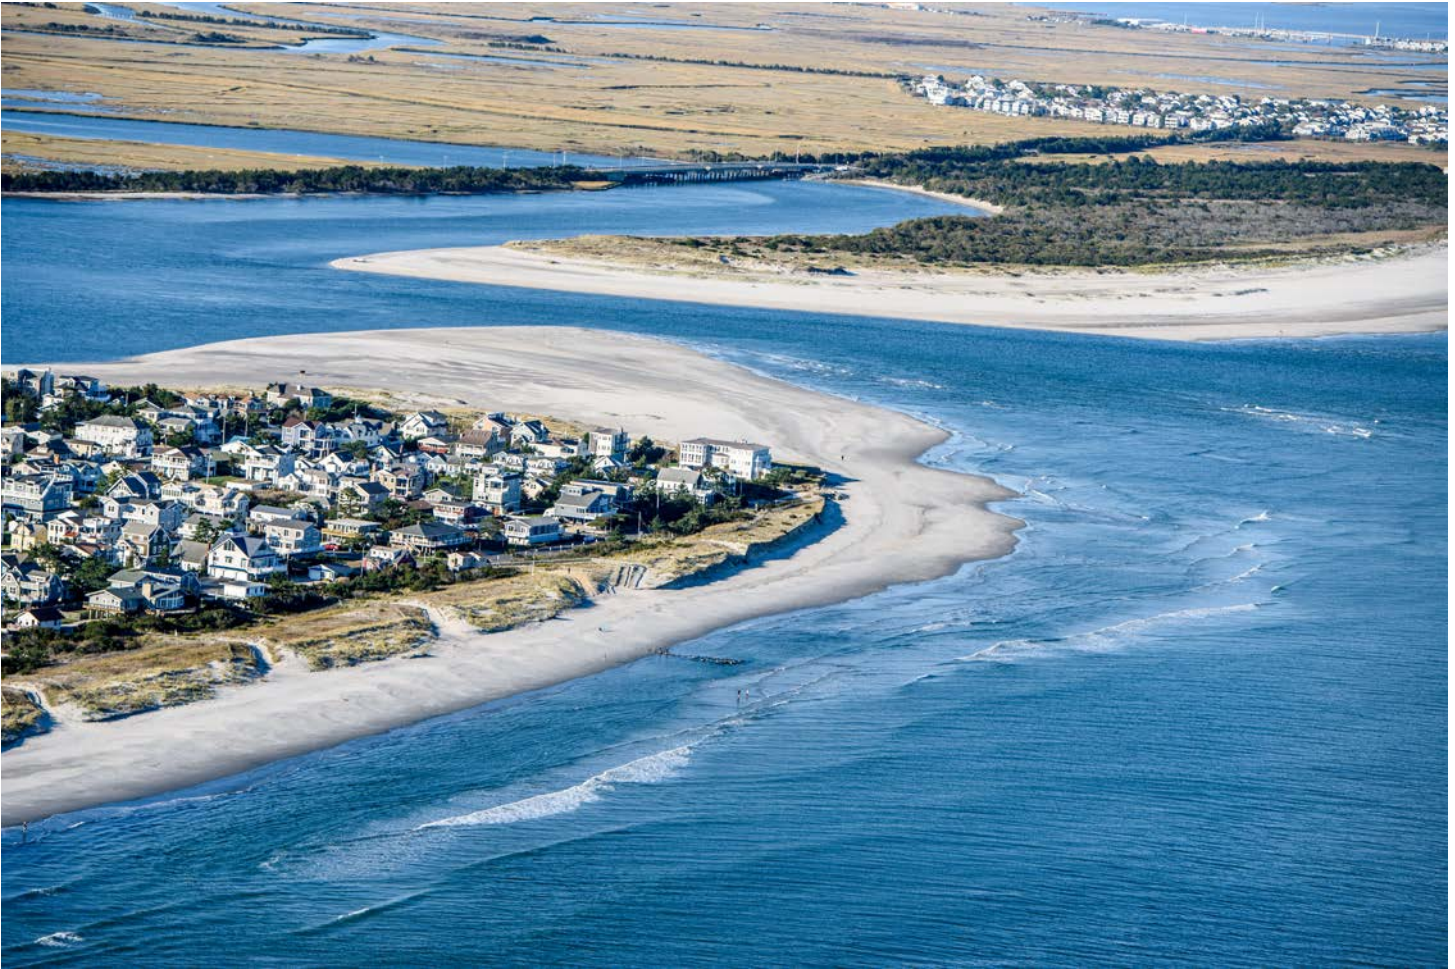
This aerial view of Strathmere, taken October 10, 2022, shows the entirety of Corson's Inlet with the offshore bar systems well defined by breaking waves near the beach and on the shoals off the south side of the inlet. The combination of wave approach and refraction around the nearby offshore bathymetry of Corson's Inlet, generates enhanced transport of sand from the oceanfront near the inlet into the main channel. The bar system is virtually emergent at this stage of the tide, as evident by the people walking on them immediately south of the exposed rock groin. The northernmost developed oceanfront is constantly under erosional stress if large offshore sand supplies are not present as a result of inlet processes. (Photo by Ted Kingston).

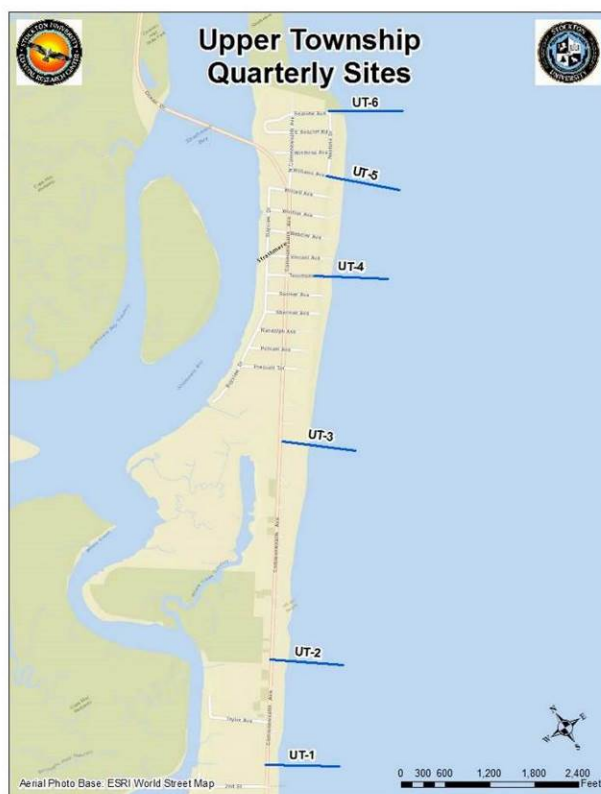
Figure 1. Locations of the 6 beach profile stations for the engineered beach in Upper Township.

The six cross sections are positioned along the Strathmere oceanfront from Seaview Avenue at the northern extent of residential development, south to the Sea Isle City boundary with Strathmere. The general locations are shown on Figure 1, page 3.

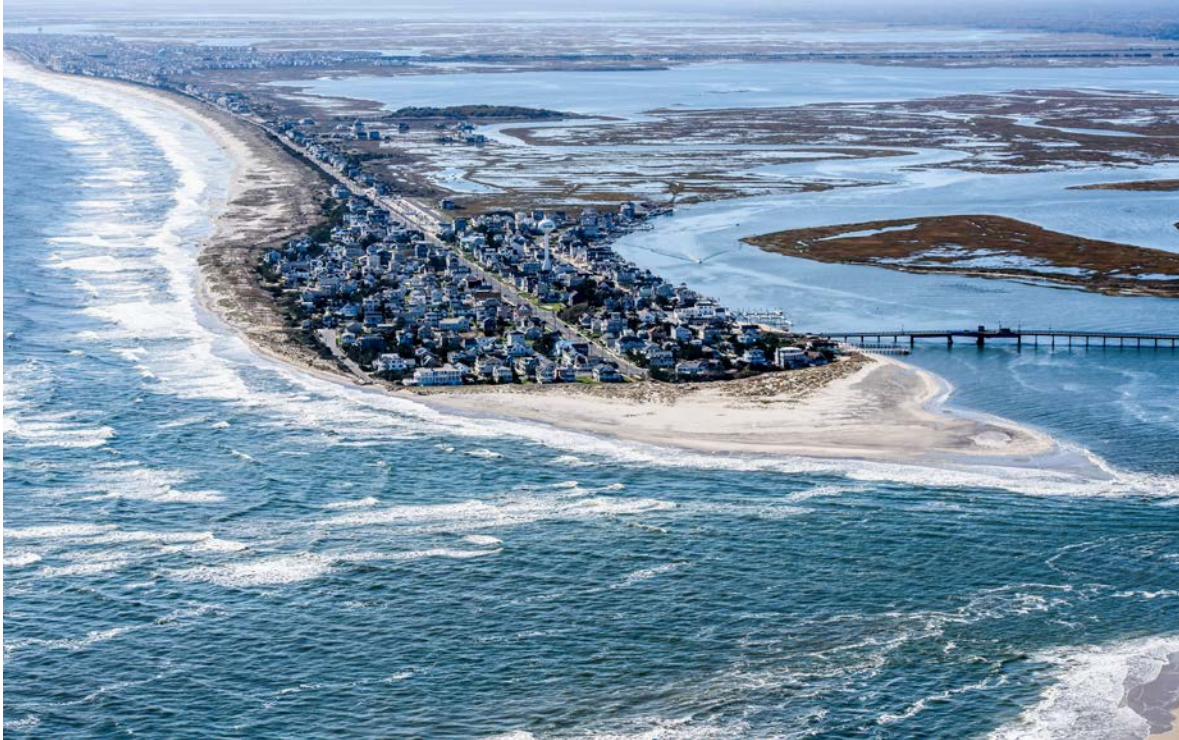
Figure 2. This October 30, 2022 photograph of Corson's Inlet and the north end of Strathmere shows the inlet shoals around the Strathmere island tip with offshore bars extending past UT-6 at Seaview Avenue. (Photo by Ted Kingston)

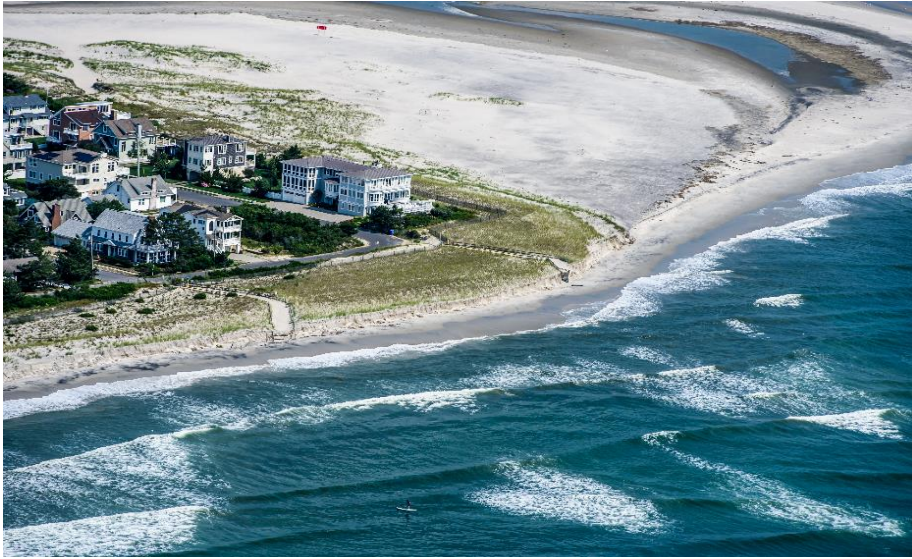
3a. July 14, 2022

Photograph 3a demonstrates just how quickly the shoreline retreats toward the dunes. Wind deposited sand at the fence line has been eroded away with the water's edge along the fencing at Seaspray Ave. as of July 2022.

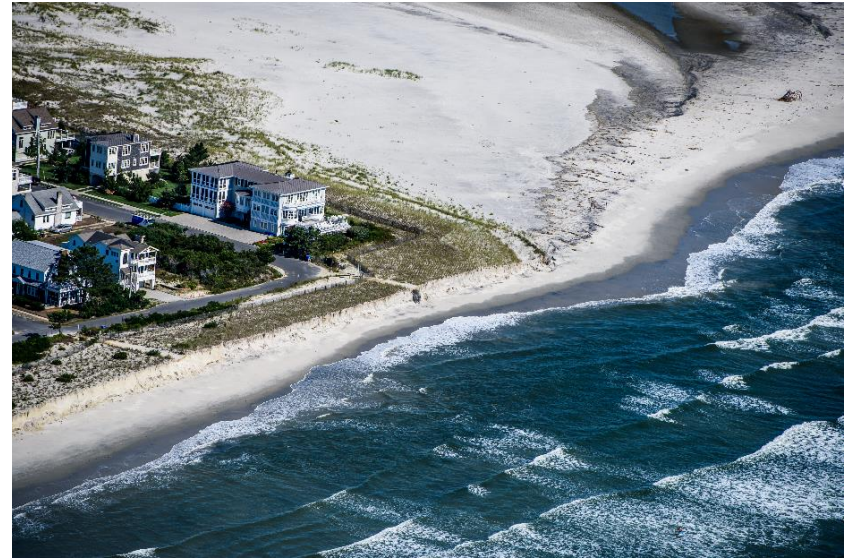
3b. August 18, 2022

Photograph 3b shows that by August 2022 the advanced dune loss has reached as far back at the dunecrest.

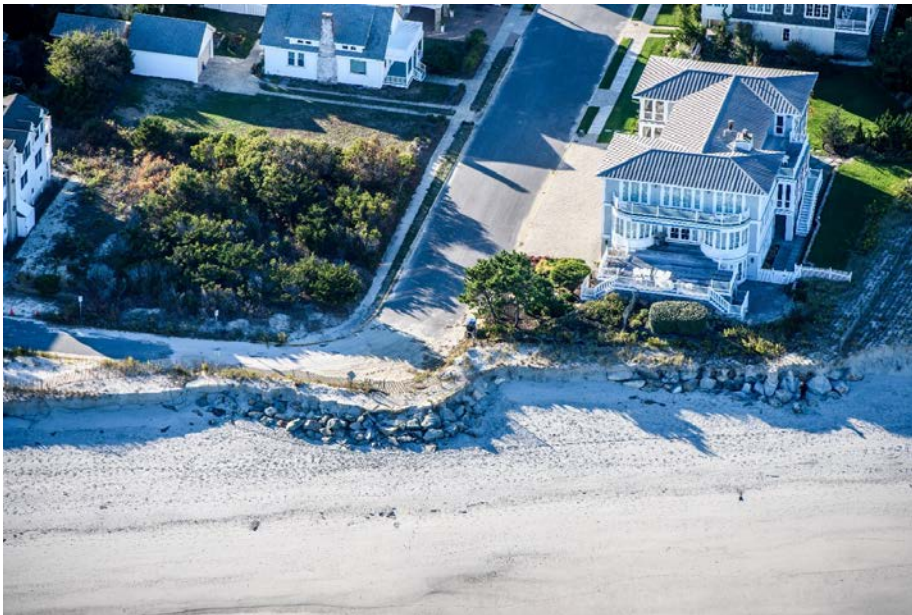
3c. October 10, 2022

Photograph 3c shows the severe erosion pattern continued at this location, exposing the rocks that provide the vital street and infrastructure protection. View to the west.

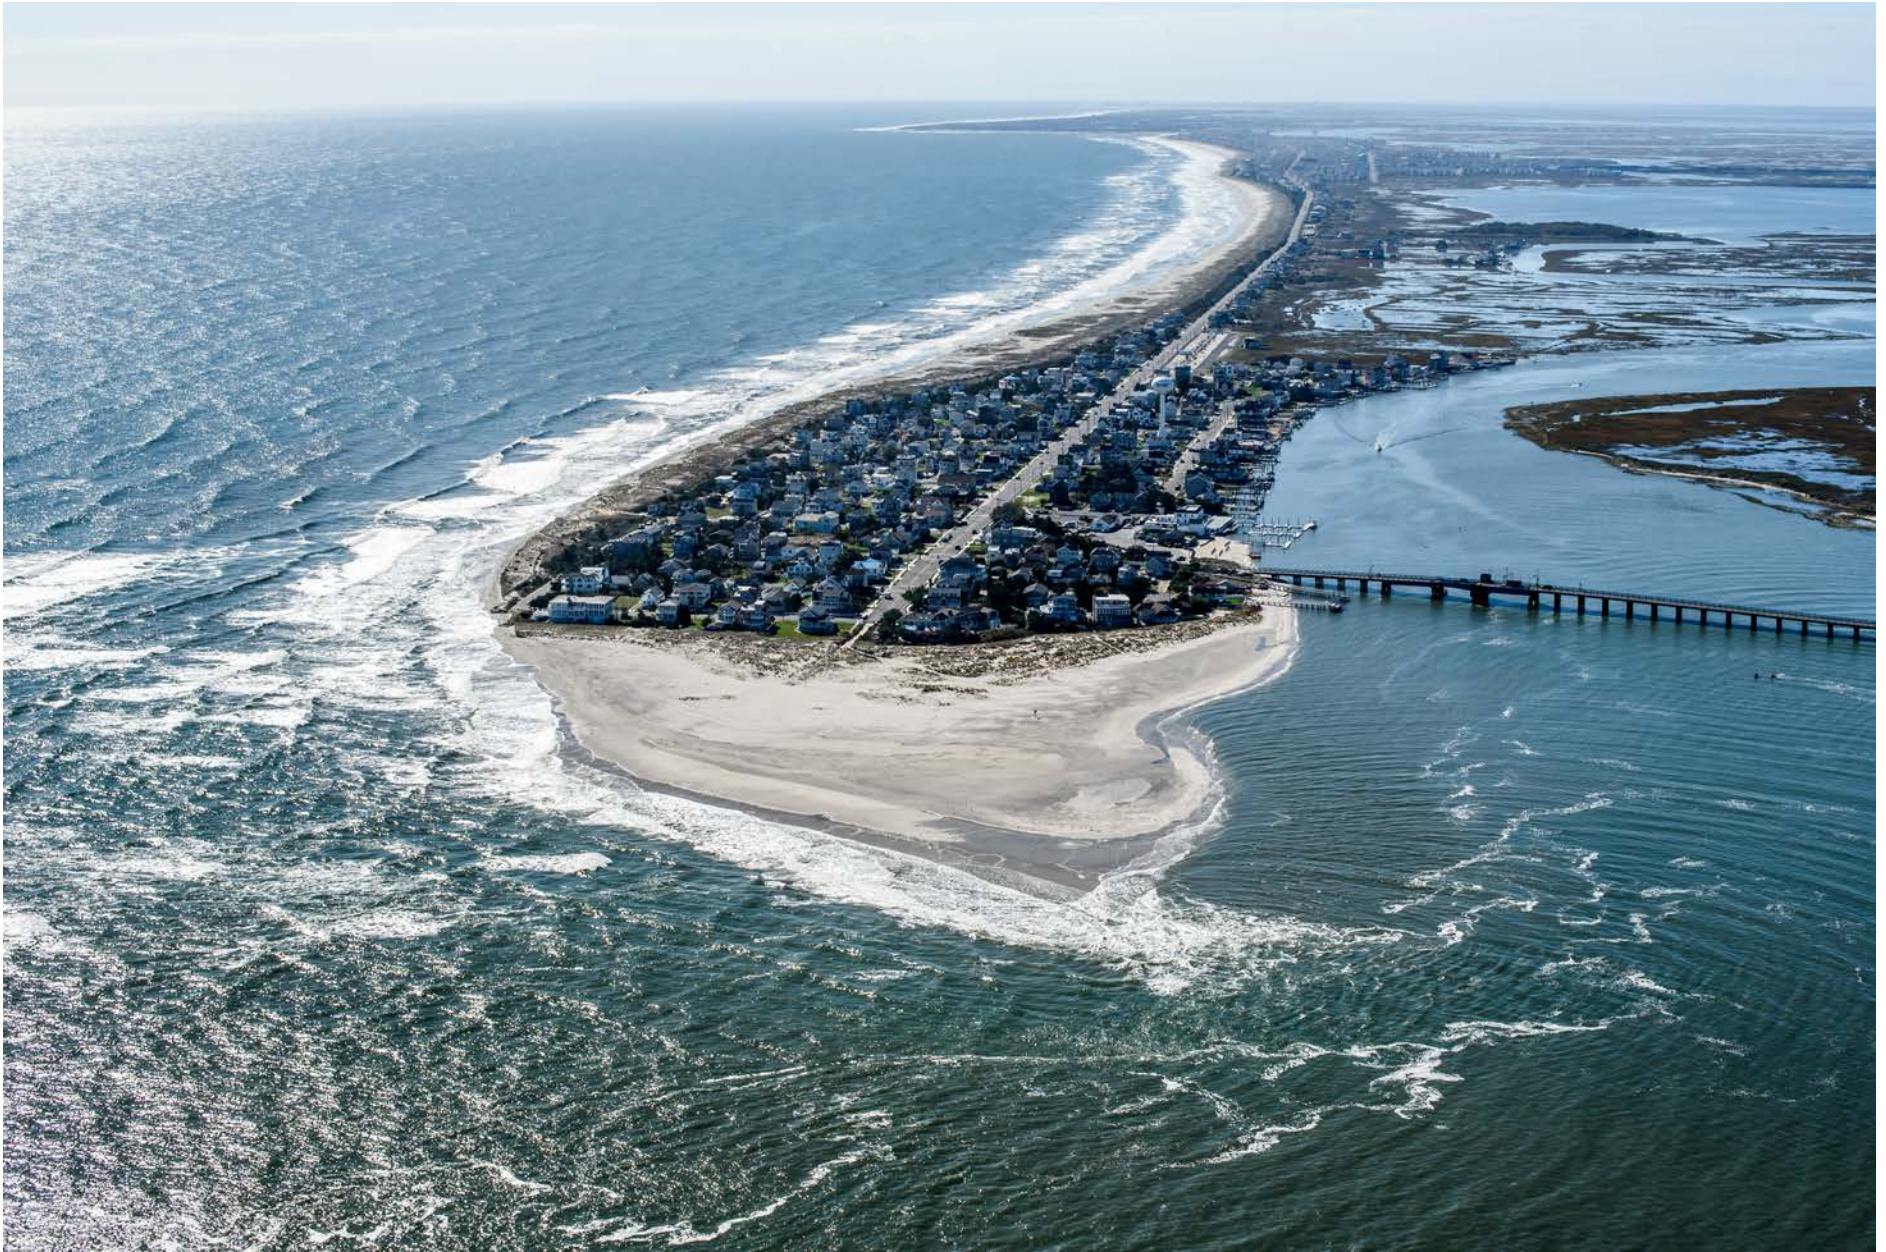
Figure 4. Aerial view of Seaview Avenue profile beach October 30, 2022, looking to the south over Corson's Inlet. The incoming breaking waves and their angle to the shoreline beach combined with the flood-tidal currents moving into Corson's Inlet, generate rapid sand transfer away from this critical region. While shallow wave-like bars still lie just offshore, the beach berm has been cut into a vertical scarp right at the end of Seaview Avenue. That scarp continues into the NJ State Park land to the northwest. Significant volumes of new sand moving north toward the inlet from the southern bar system is required if the erosion is not to move into the 2019-2020 USACE rebuilt dunes this winter.

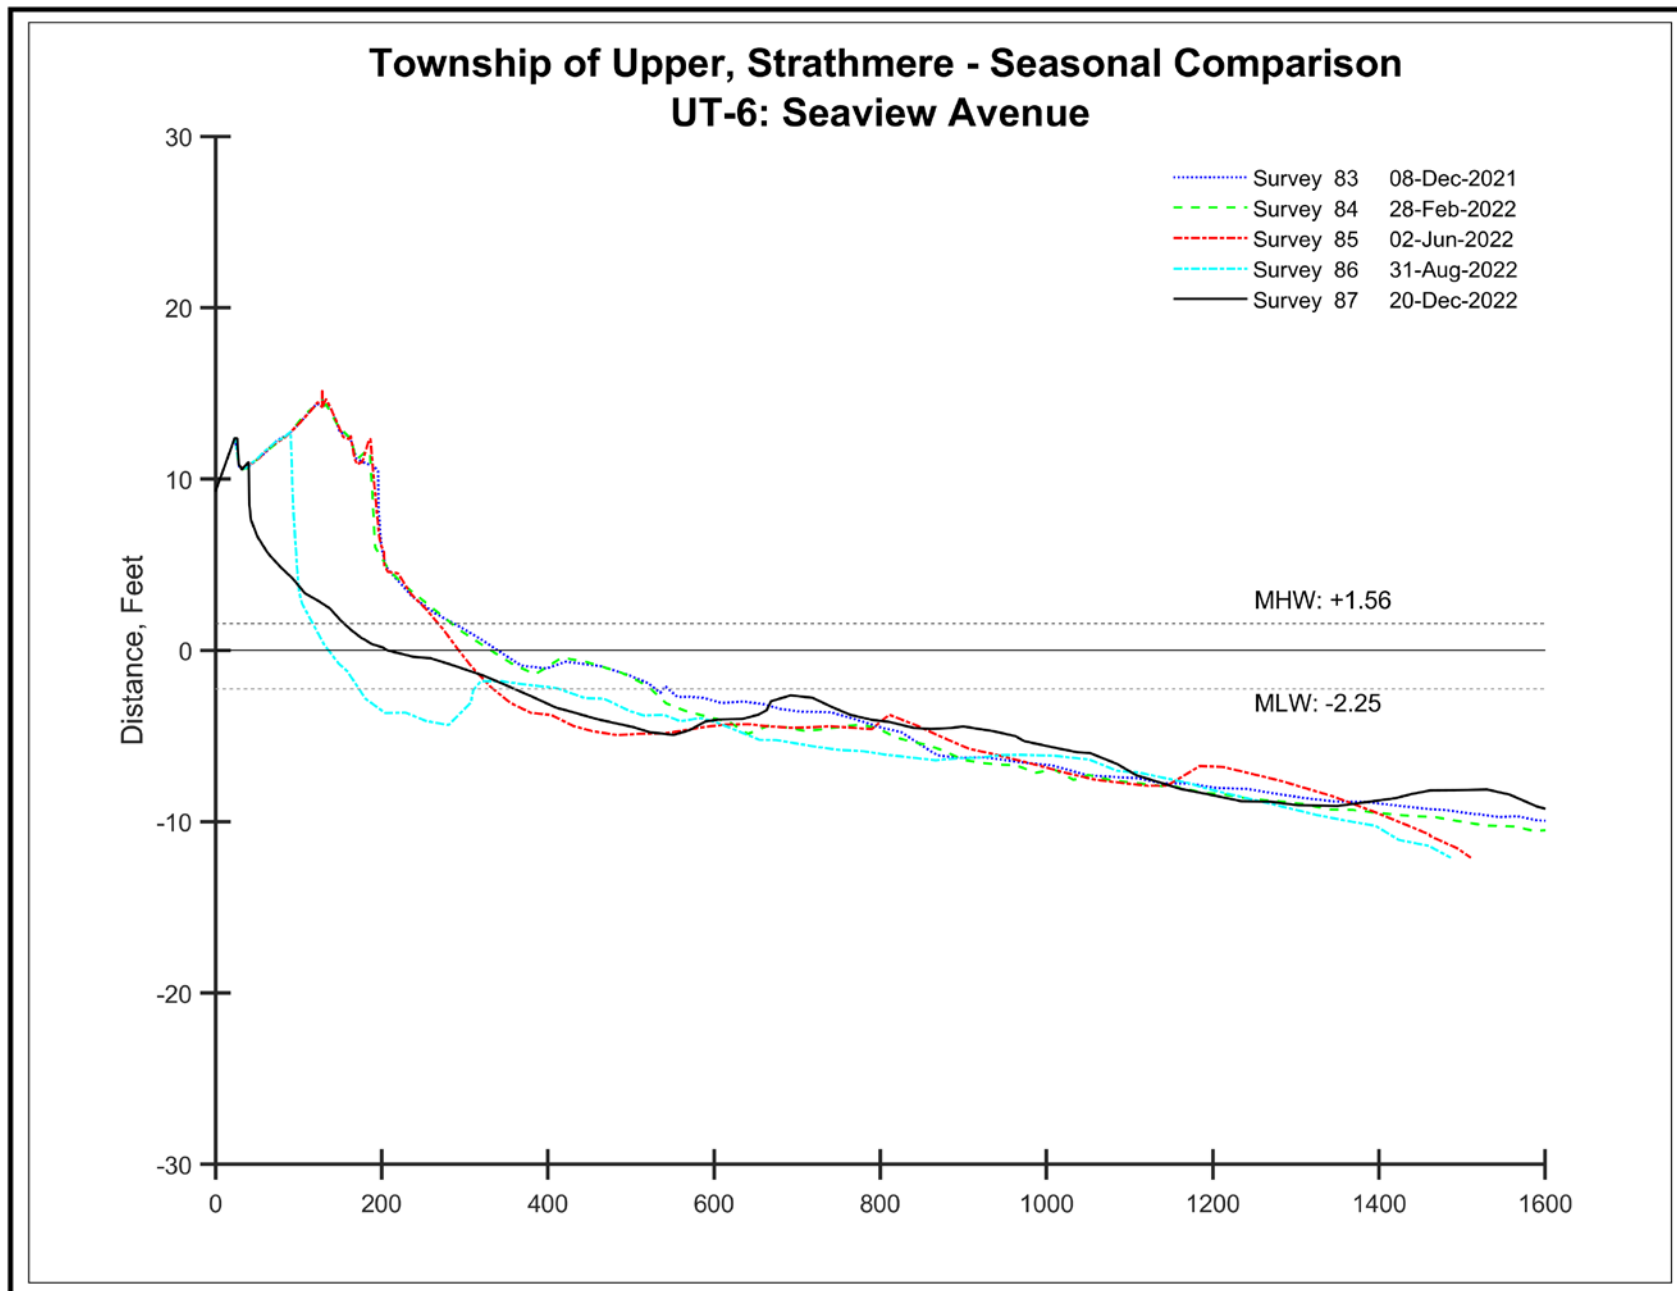
Figure 5. This 2022 sequence of surveys illustrate the rapid shoreline retreat. The August 31, 2022, survey at UT-6 provides a stark view of the dune erosion since June. Previous losses had been relatively minimal, but in the three months, the net loss in sand volume is 84.92 yds³/ft. with a 157-foot shoreline retreat. By December 2022, the nearshore bar approached the shoreline slightly elevating the lower recreational beach, but the sand quantity is insufficient to moderate the situation.

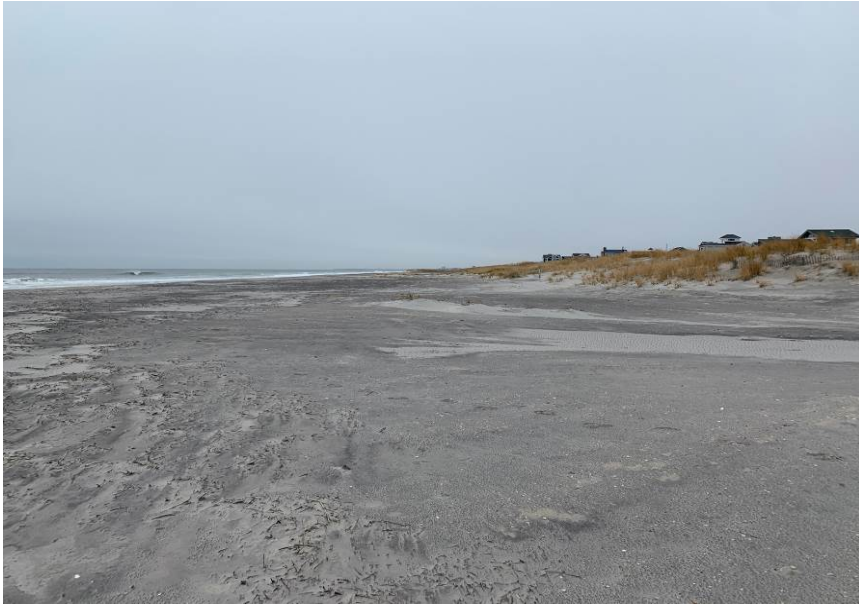
6a. December 8, 2021

Figure 6a. The December 2021 view from the upper beach area shows the decreased width, but no dune damage to date.

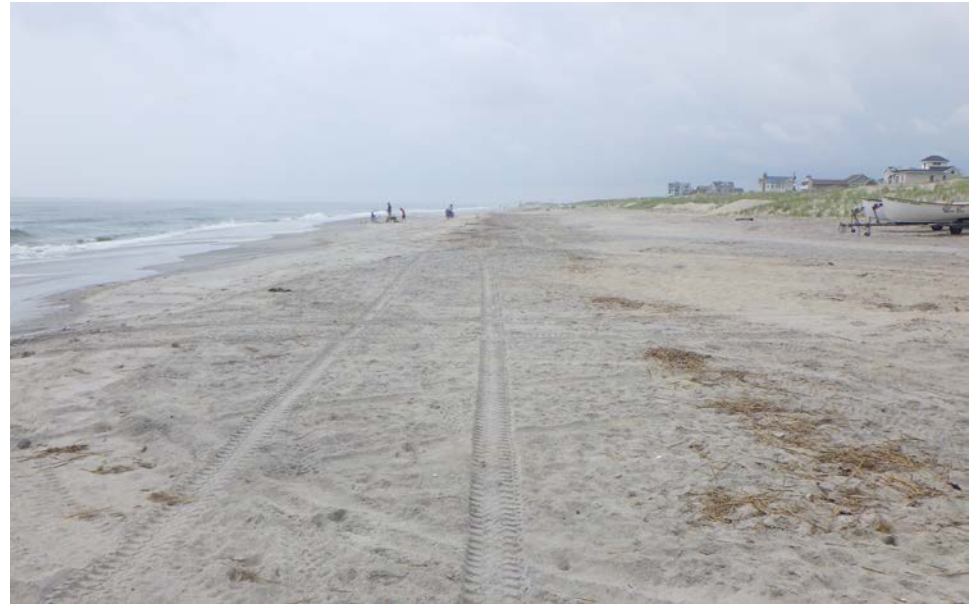
6b. June 3, 2022

Figure 6b was taken in June 2022 looking south across the central region along the berm. Erosion to the beach width berm has taken place.

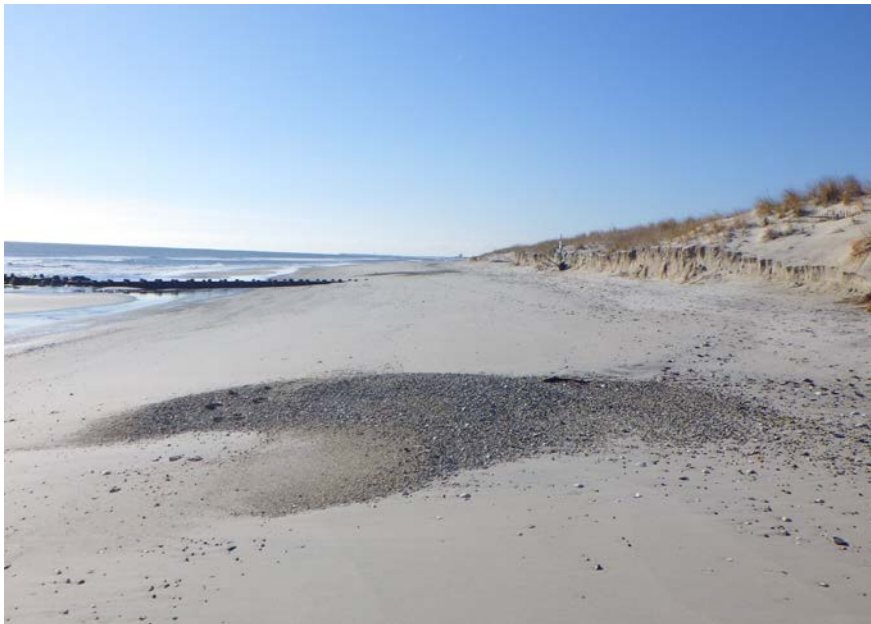
6c. December 20, 2022

Figure 6c. View to the south along the upper recreational beach. Severe erosional processes have further cut into the beach and dunetoe, creating a distinct scarp cut into the dune.

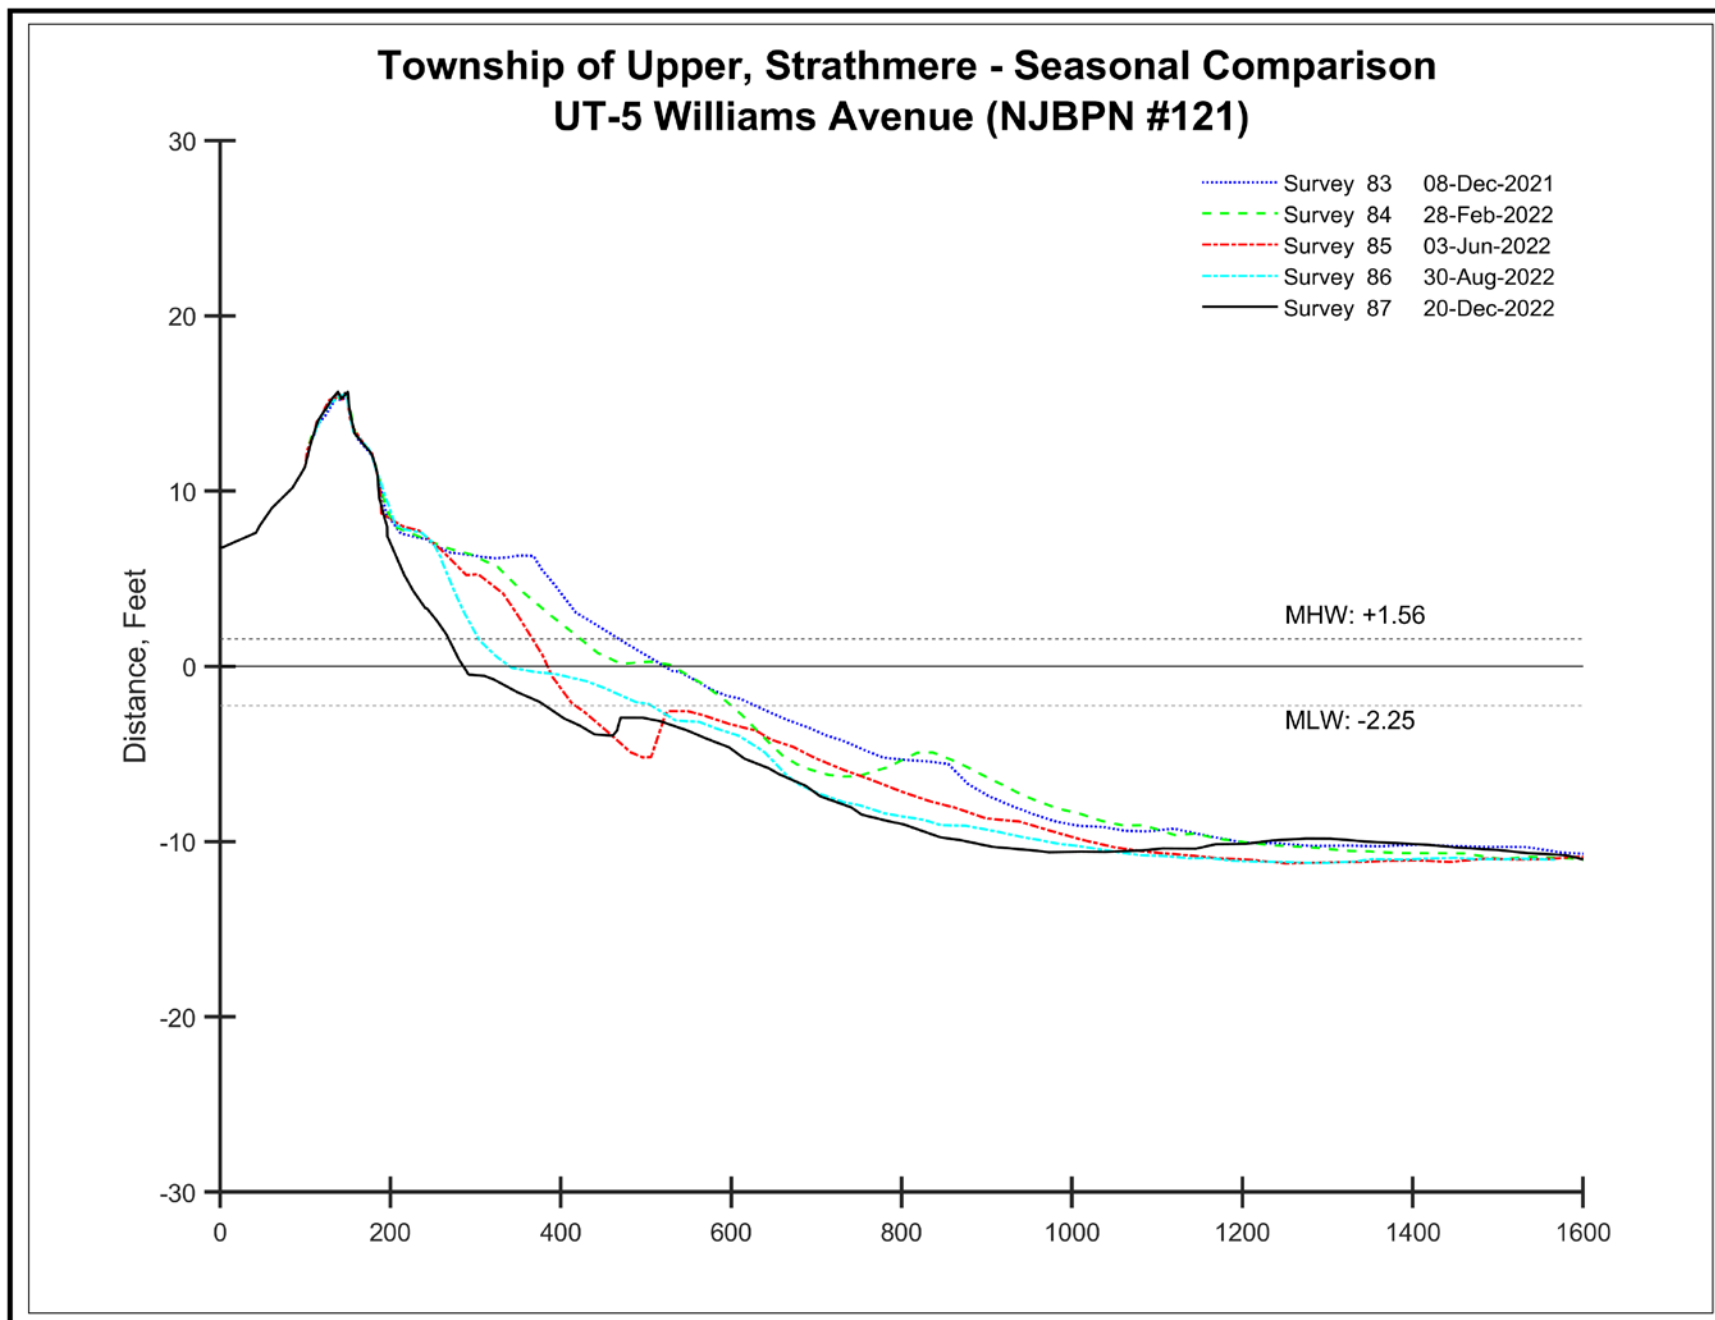
Figure 7. At Williams Avenue, beach retreat over the summer lost 45 feet of shoreline landward as the beachface eroded. Sand was deposited immediately offshore filling in the June trough. The last quarter of 2022 displayed continued losses to the beachface and nearshore regions. Overall losses for the annual comparison amounted to the largest of the 6 profiles with 236 feet of shoreline and 131.05 yds³/ft. of sand.

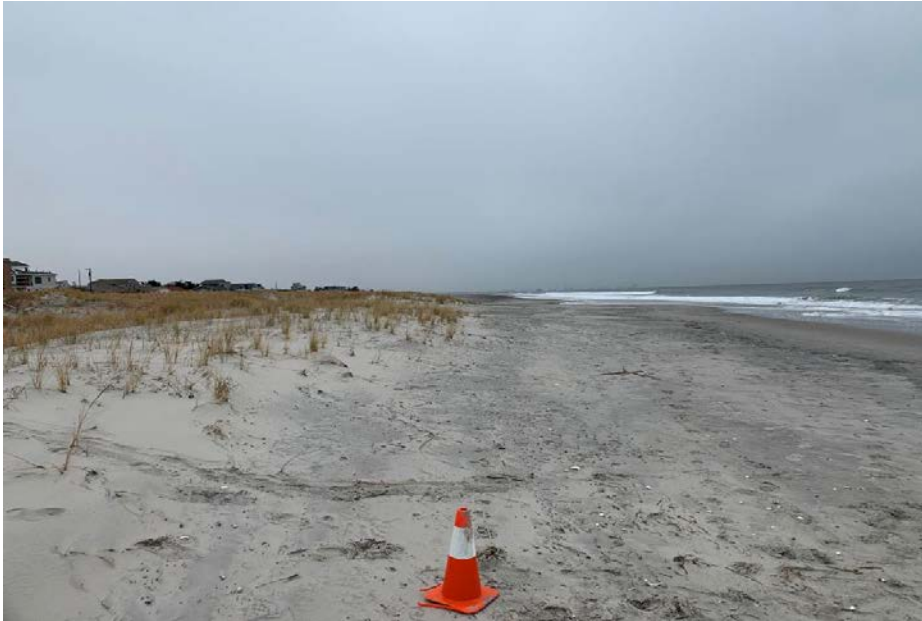
Figure 8a. December 8, 2021

Figure 8a. The December 2021 view to the north along the mid-beach foredune system shows a developing array of dunes normally expected to become a primary dune field.

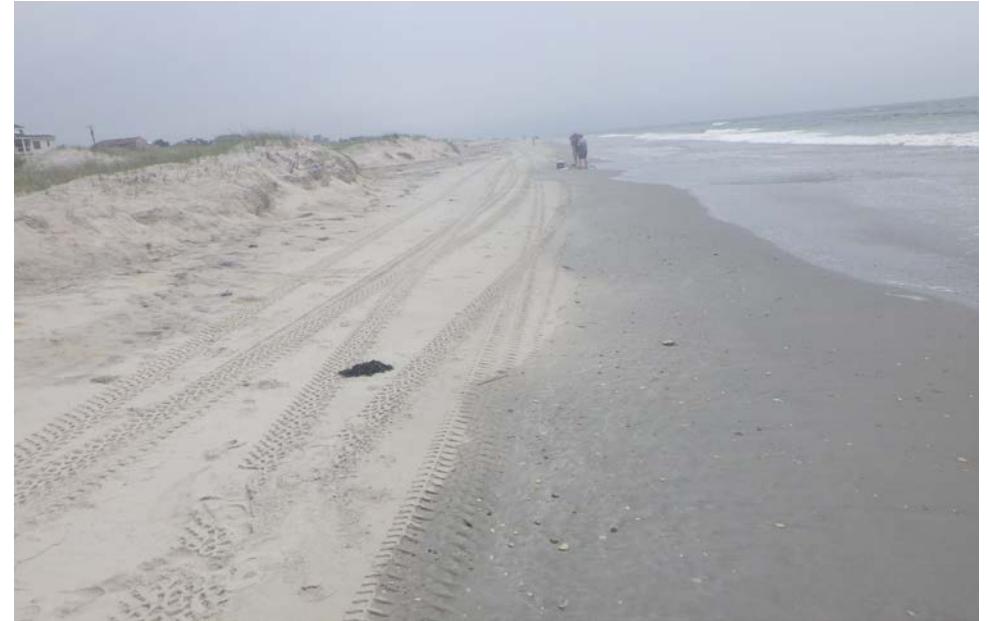
Figure 8b. June 3, 2022

Figure 8b. The June 2022 photograph shows recreational and berm losses have taken place leaving only a narrow area of dry beach at high tide.

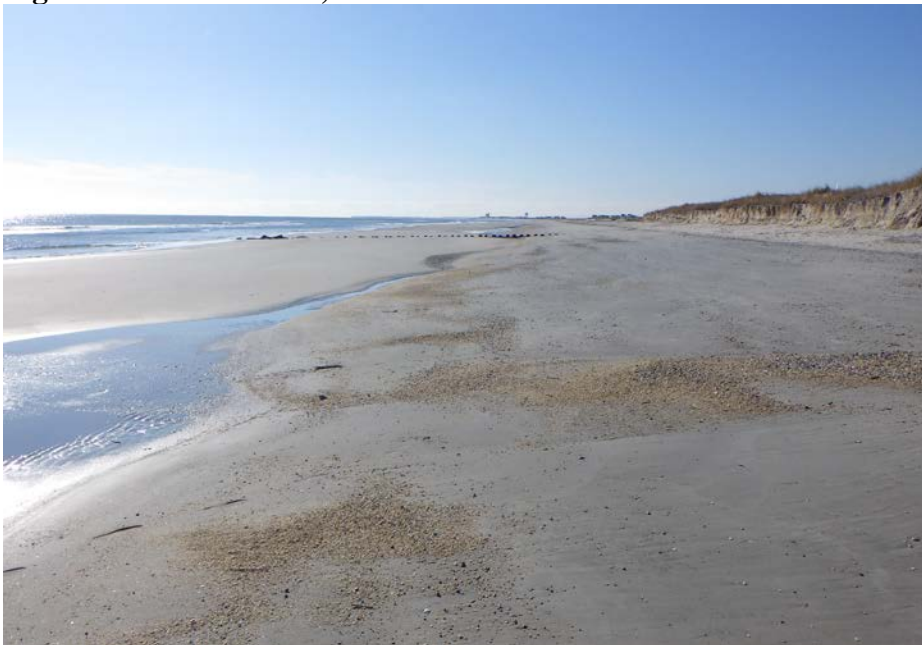
Figure 8c. December 20, 2022

Figure 8c. View to the south in December 2022. The entire beach remains wet while significant erosion into the dune has occurred, revealing a 3-to-5-foot scarp into the dunetoe. Notice the exposed timber pilings from the formerly buried wooden groin.

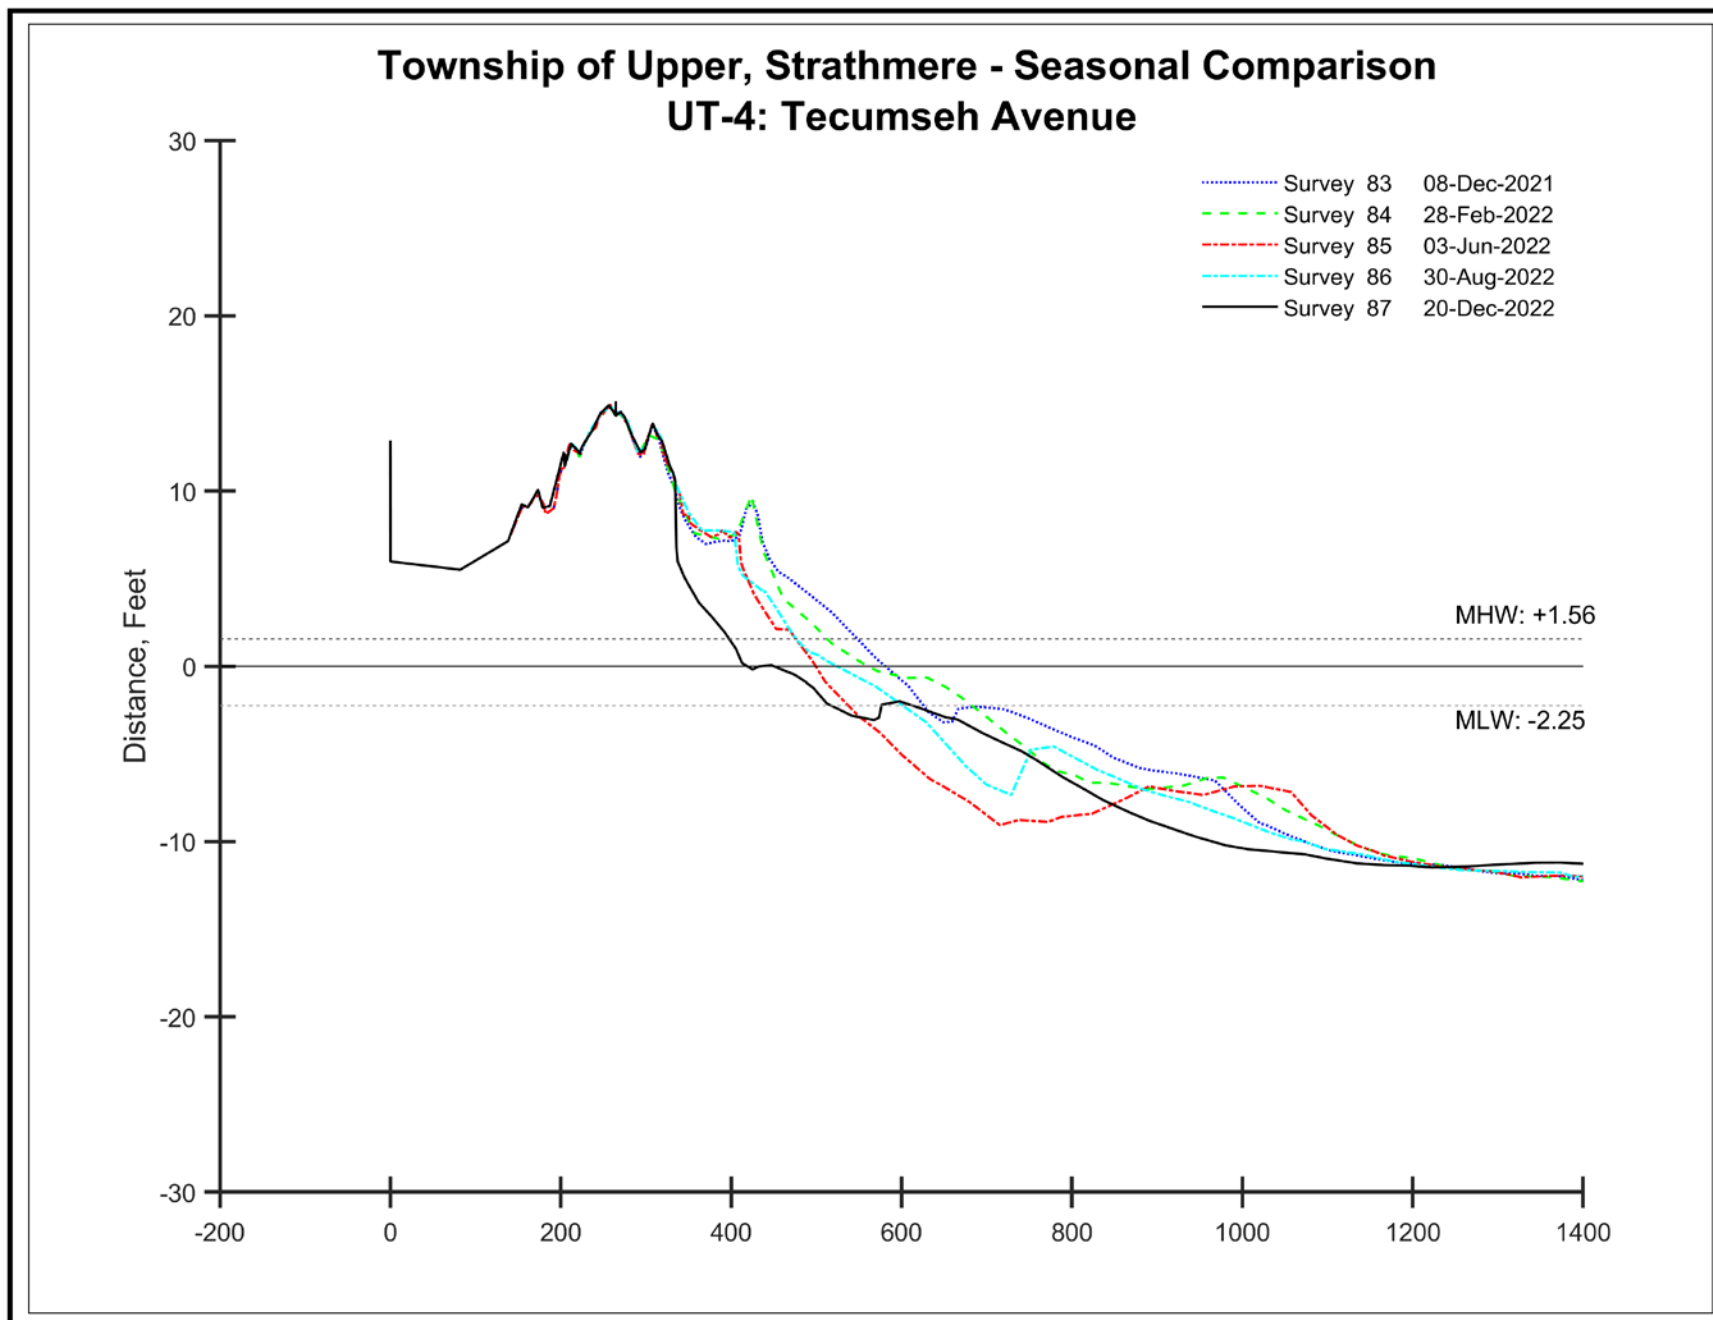
Figure 9. This location suffered beach retreat up to the December 2022 survey. Over 130 feet of shoreline retreat with 72.64 yds³/ft. of sand volume losses were recorded when comparing the annual December surveys. A significant offshore bar displayed in previous surveys has shifted outside the profile limits.

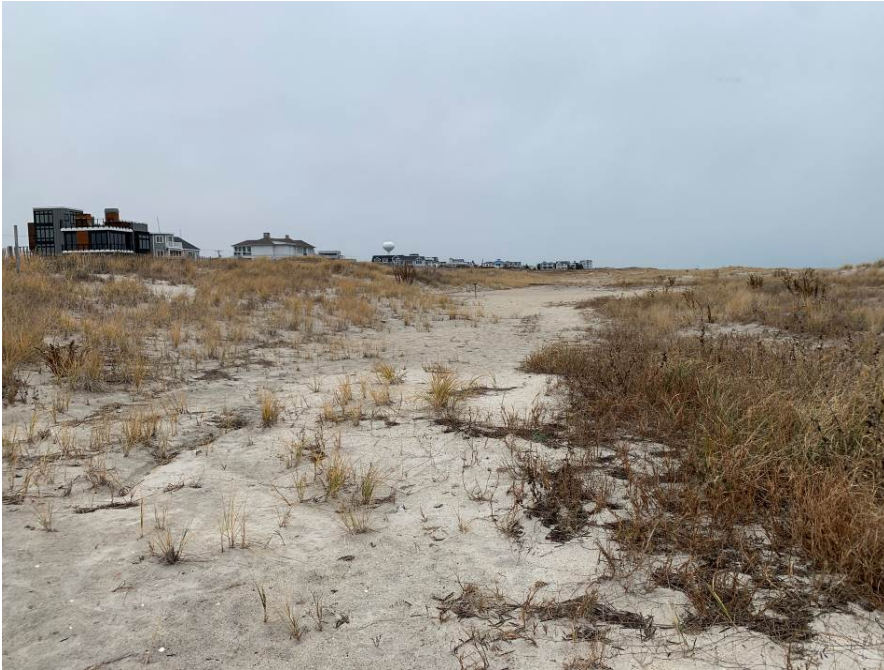
10a. December 8, 2021

Photo 10a. The valley between the old primary dune and its buried fencing is between a vibrant new foredune system rapidly becoming the main area where new sand is added.

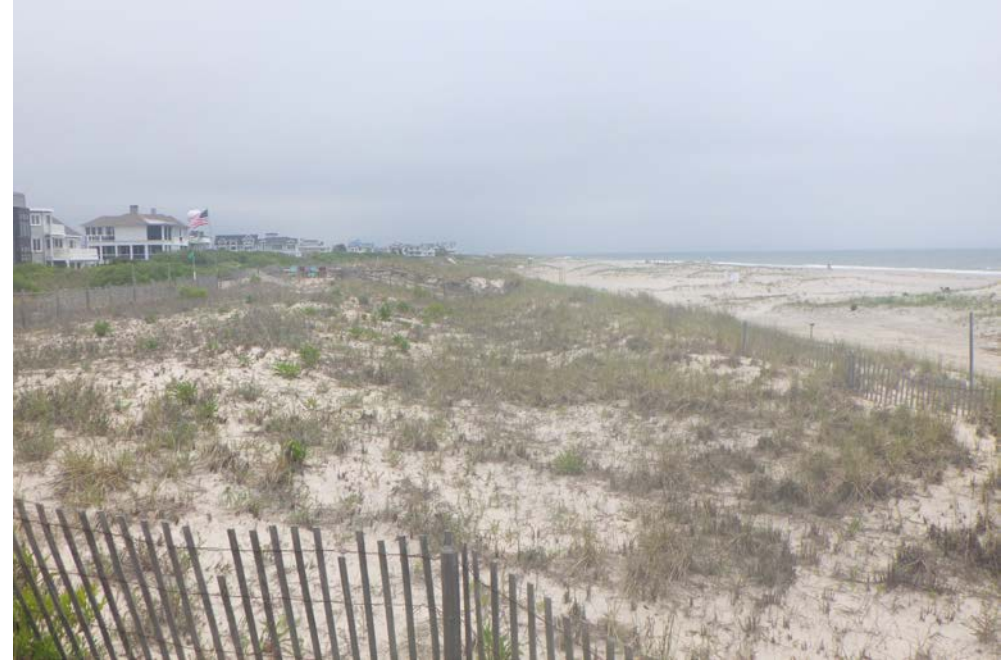
10b. June 3, 2022

Photograph 10b View to the north in June displaying the wide healthy primary and foredune system.

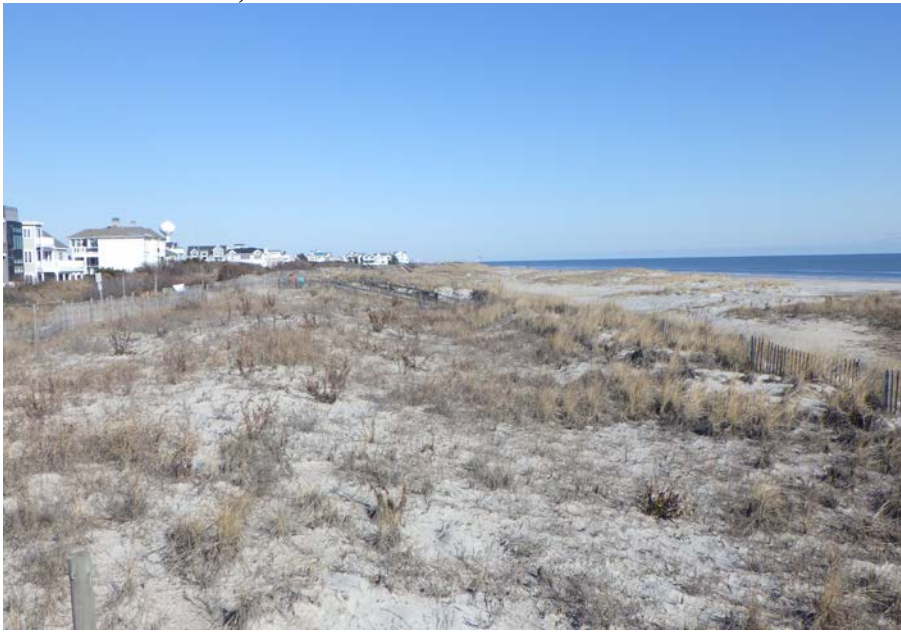
10c. December 20, 2022

Photograph 10c. The December 2022 view looking to the north, shows that the entire dune system remained unscathed by erosional forces and continues to flourish.

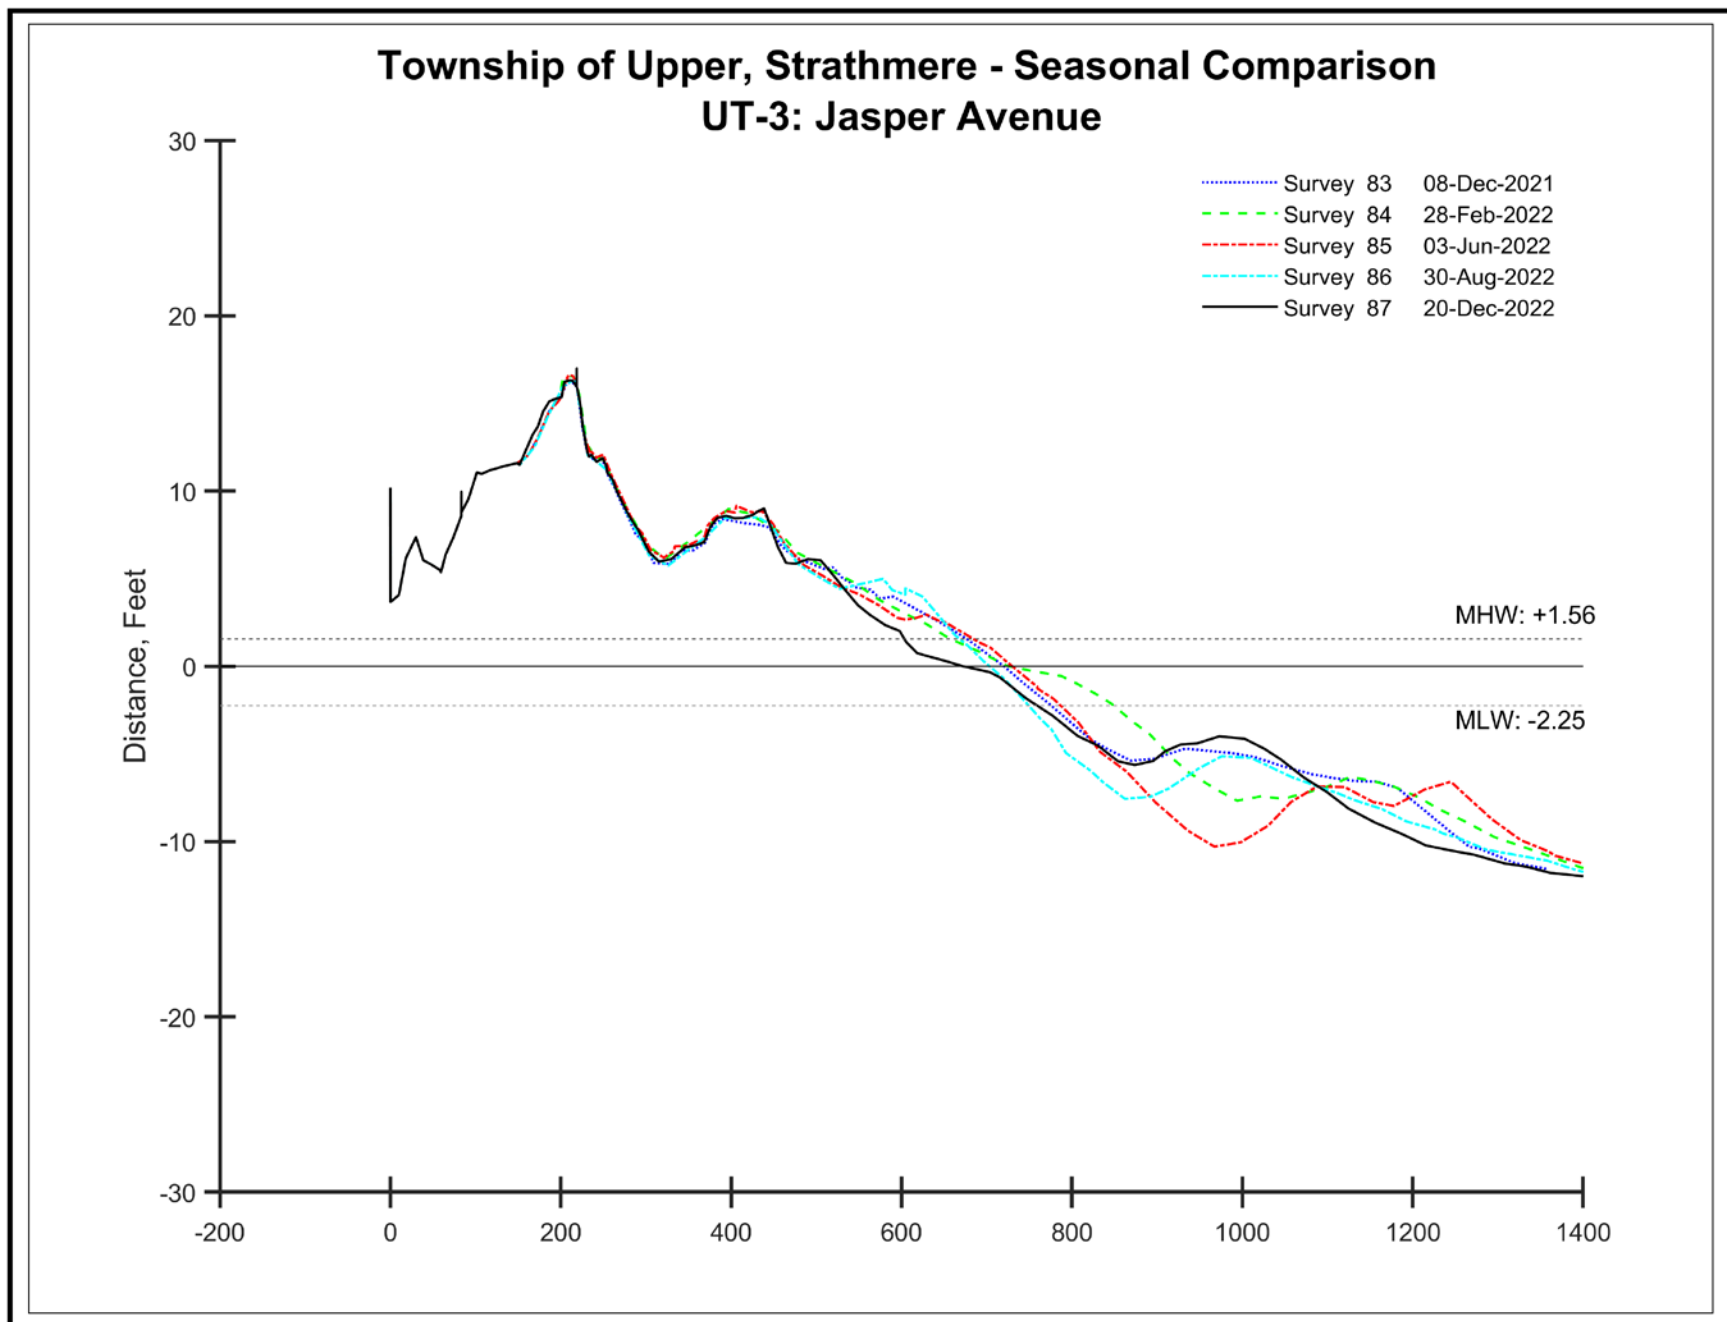
Figure 11. The berm position that was present through August 2022 had eroded by December as sand shifted to the offshore bar, in the process filling in the nearshore trough. Both the primary and the foredune remained intact throughout this study interval. For the annual comparison, the sand volume declined by 20.63 yds³/ft. across the entire transect line coupled with a shoreline retreat of 48 feet.

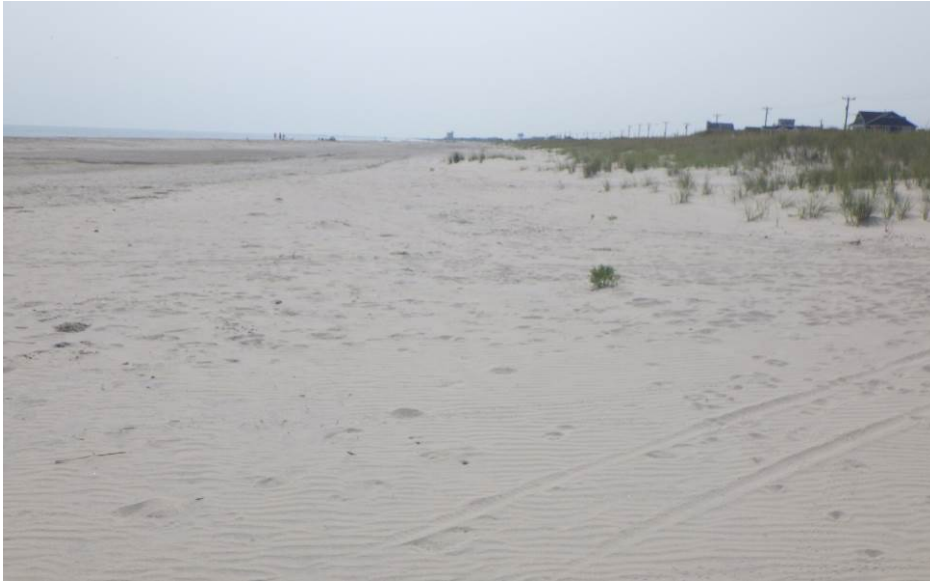
12a. September 12, 2021

Figure 12a. This view in September depicts wind deposition into the new grass at the dune toe with minor change obvious in the general beach condition.
