UPPER TOWNSHIP MUNICIPAL SHORELINE MONITORING

2022 ANNUAL REPORT (covering monitoring activities January 2022-December 2022)

**FINAL REPORT FOR 2022
ON THE CONDITION OF THE MUNICIPAL BEACHES
IN
THE TOWNSHIP OF UPPER, CAPE MAY COUNTY, NEW JERSEY**

**Annual Report for 2022
To
The Township of Upper
On the Condition of the Municipal Beaches in Strathmere**

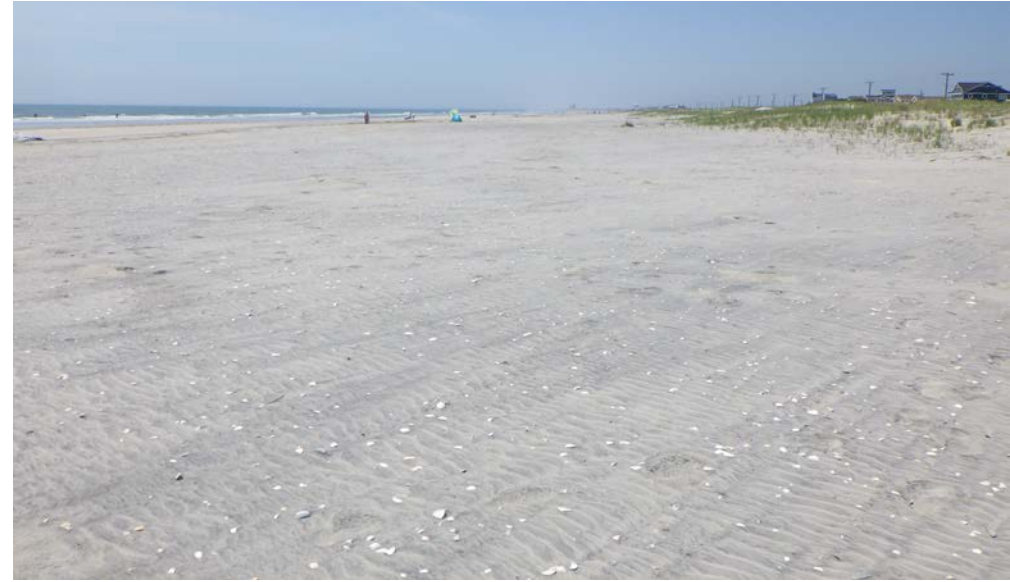
12b. June 2, 2022

Photograph 12b taken on a bright sunny day looking south along the foredune toe.

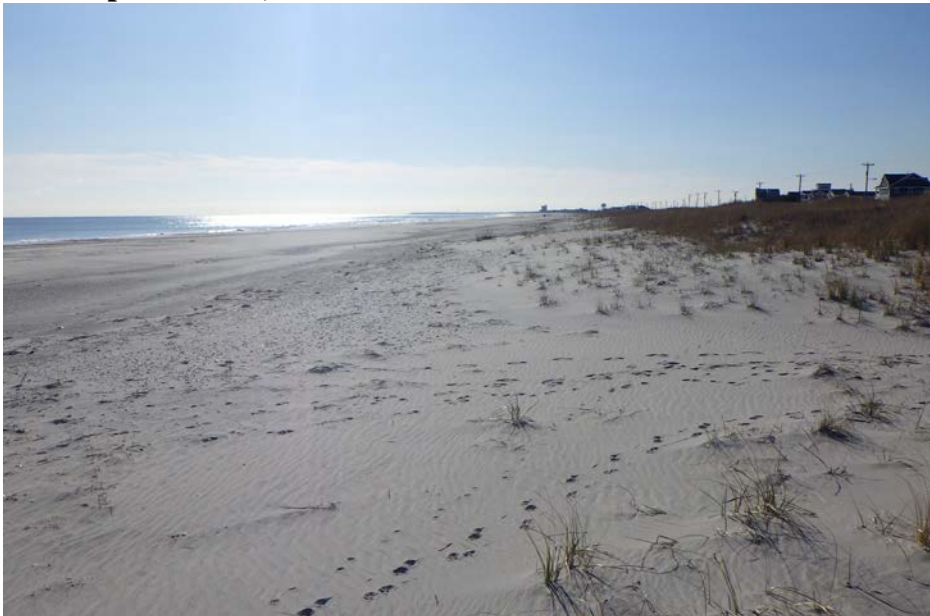
12c. December 20, 2022

Photograph 12c. This view in December displays continued wind deposition into the grass at the dune toe with increases to the berm width and elevation since the summer survey.

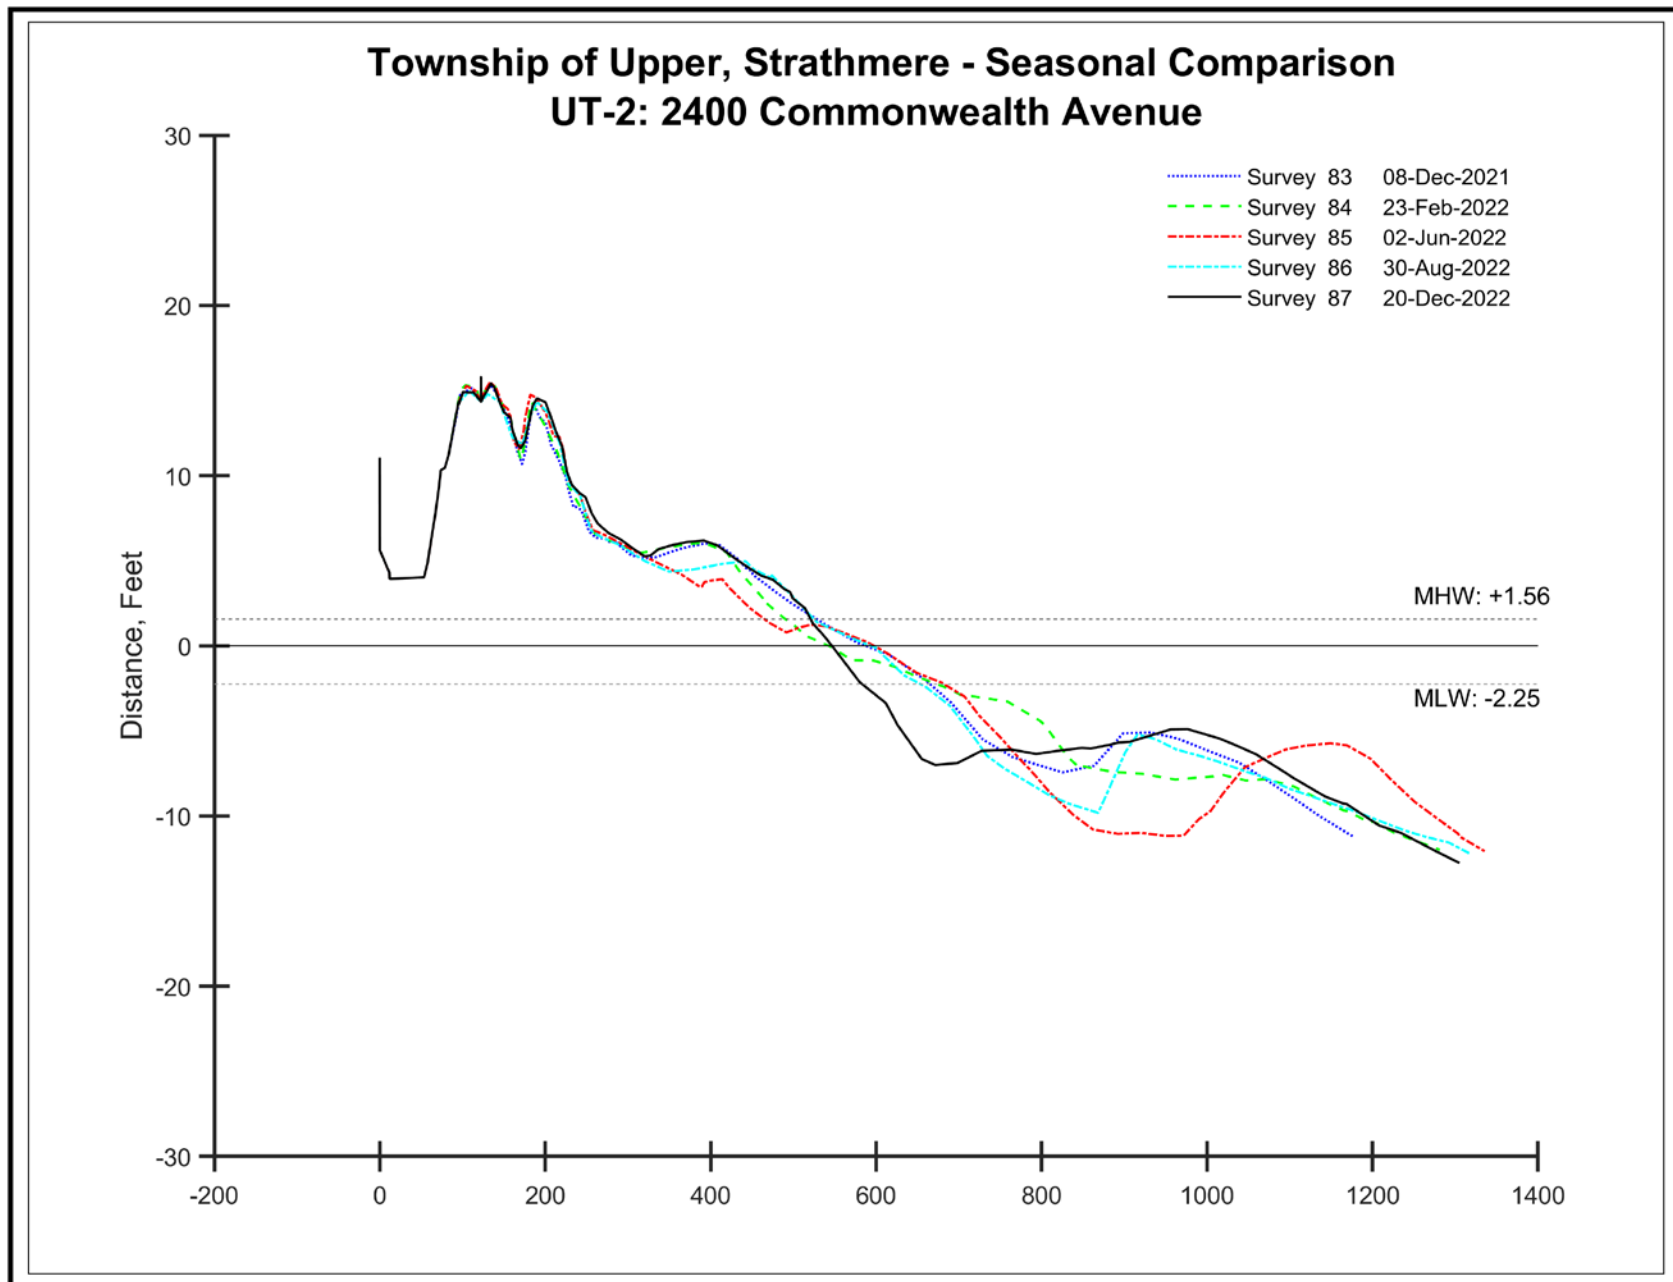
Figure 13. The primary dune developed a significant foredune nearly at the same elevation as the reference position on the original dune. Berm growth did not reach the 2021 proportions by December 2022 as the nearshore sand welded to the beachface. Significant offshore bar advancement can be seen since the August survey. Between surveys 86 and 87, the seasonal loss was 47 feet of shoreline with 8.15 yds³/ft. net gain in sand volume.

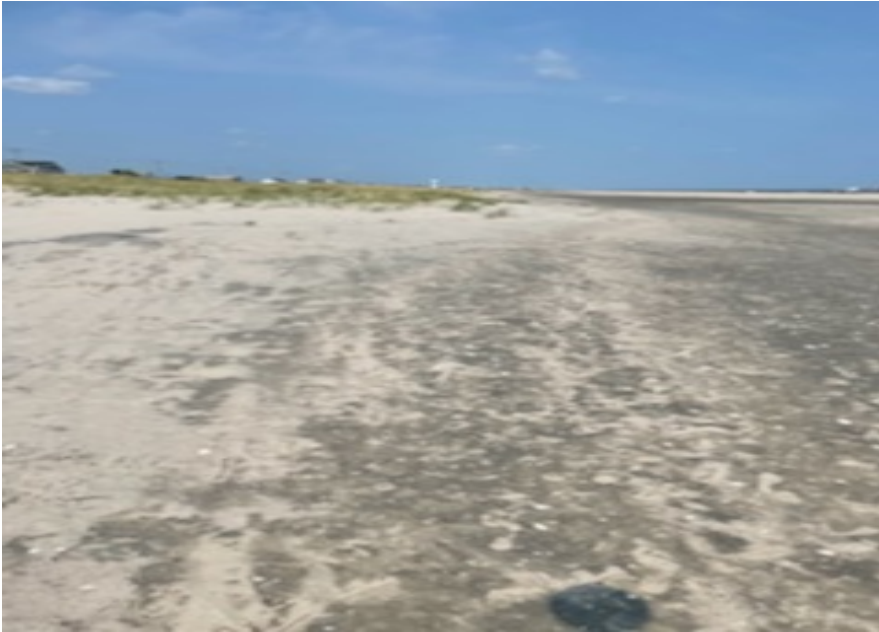
14a. September 13, 2021

Photograph 14a. This early fall view shows the beach width re-established since the summer after the offshore bar moved onto the beach.

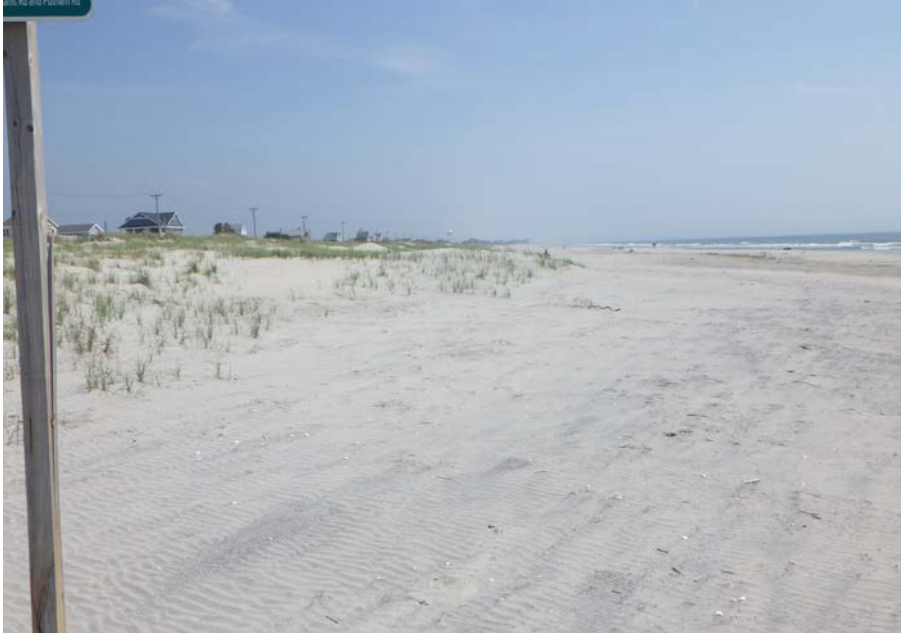
14b. June 2, 2022

Photograph 14b. View to the north along the dunetoe in June 2022. Slight accretion can be seen in the seaward foredune slope.

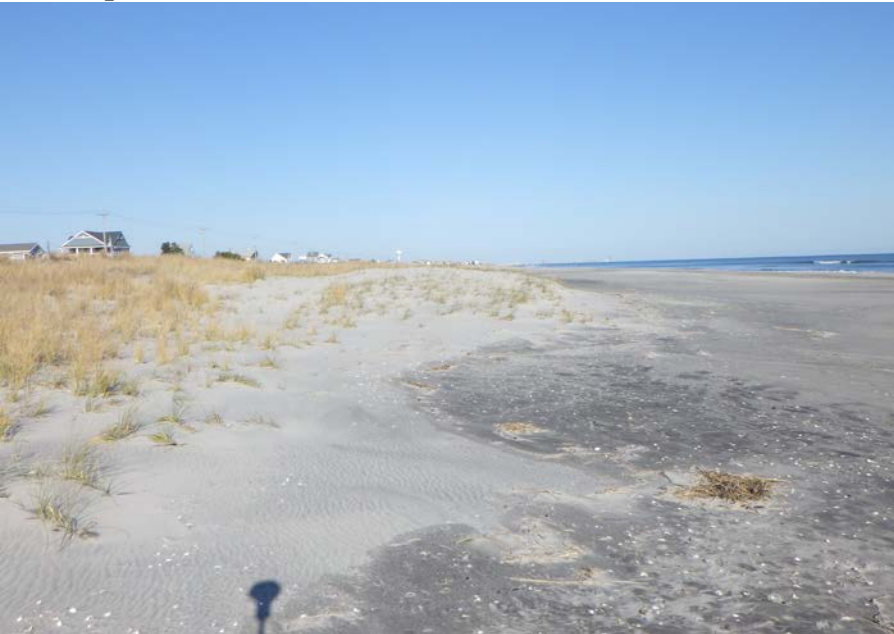
14c. December 20, 2022

Photograph 14c. This December 2022 view shows the beach width and dune system remains in-tact.

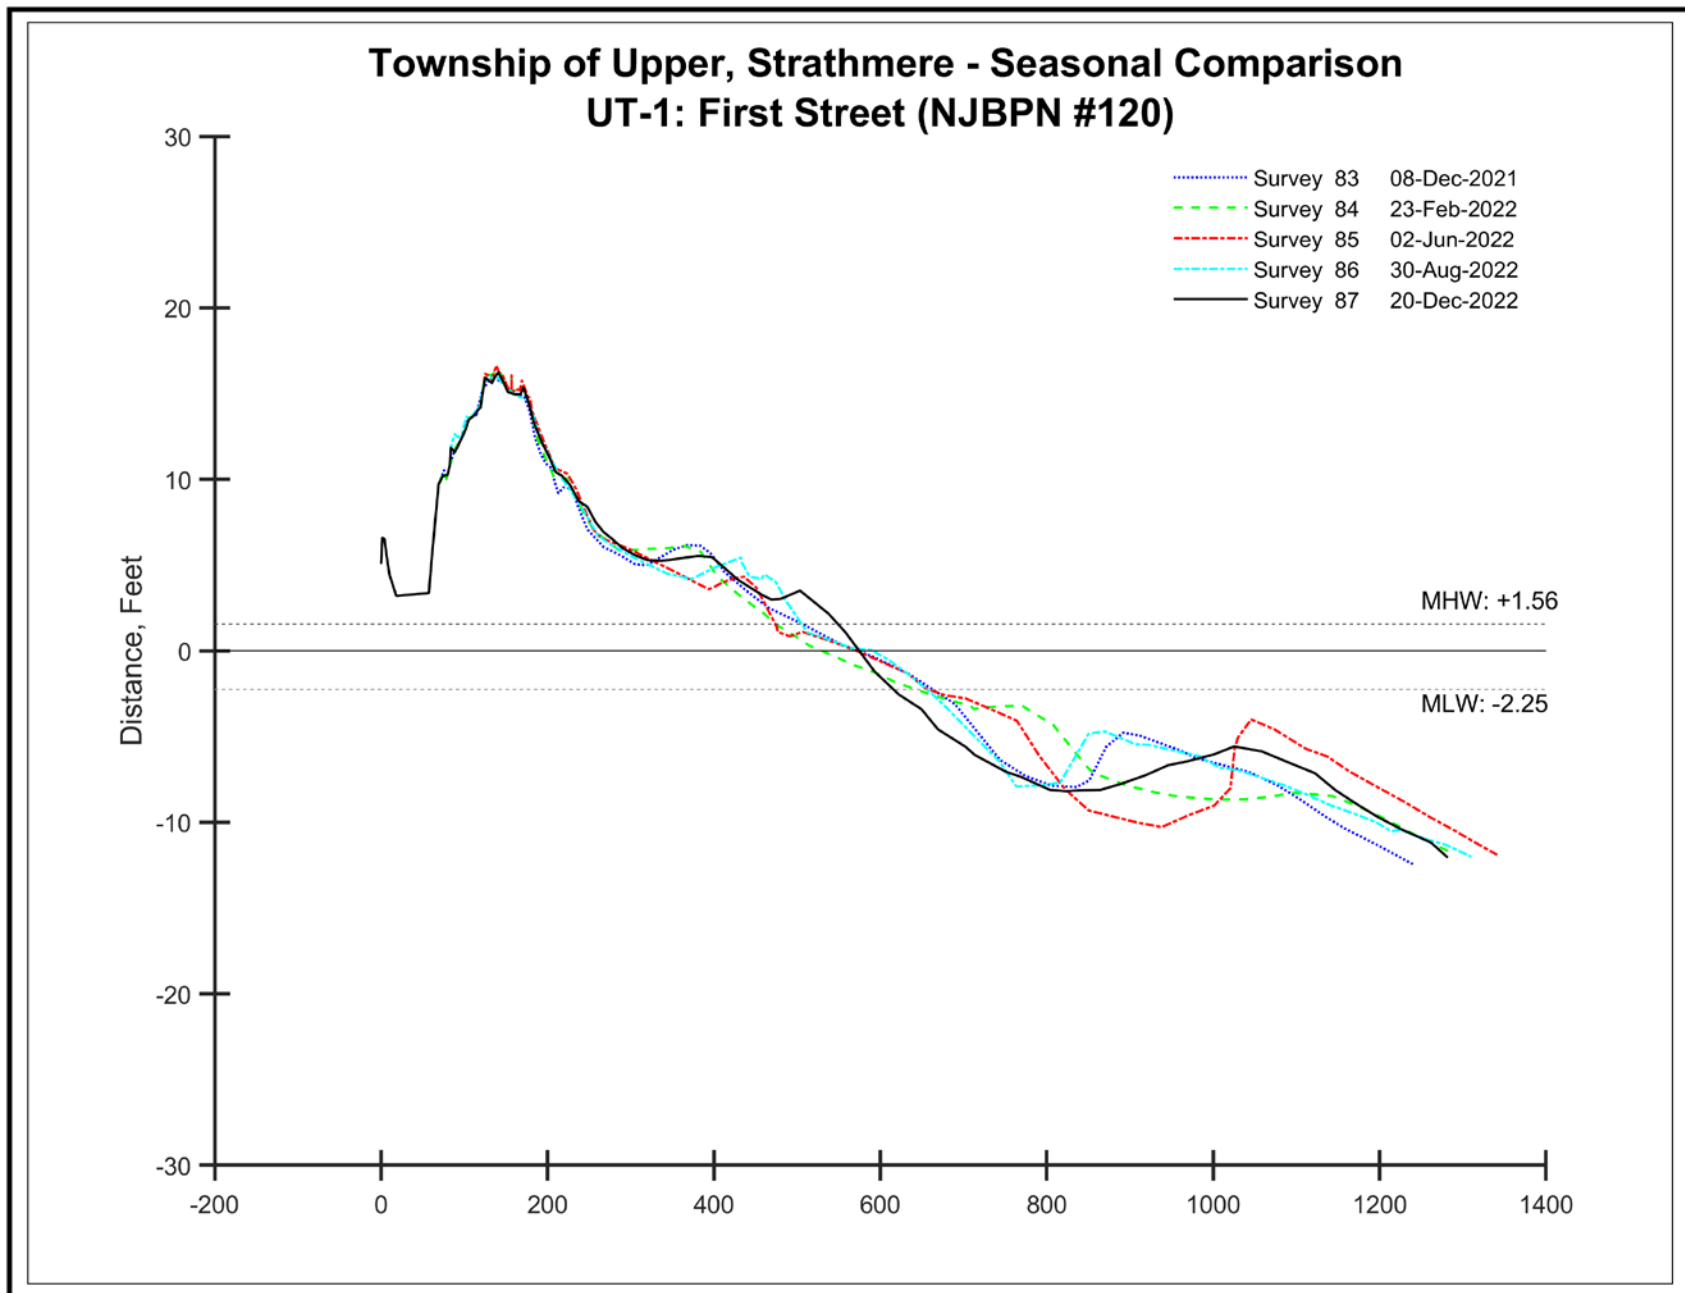
Figure 15. Seasonal variations appear well illustrated in this site's five transects. A double-tiered berm developed by the final survey as nearshore material made its way to the beachface. The pronounced offshore bar that was present in August had returned by December, though not as elevated. The primary dune remained virtually unchanged for the entire study period. Despite the offshore topography changes, this site managed a relative equilibrium with 4.28 yds³/ft. of sand gain recorded over the 12 months.

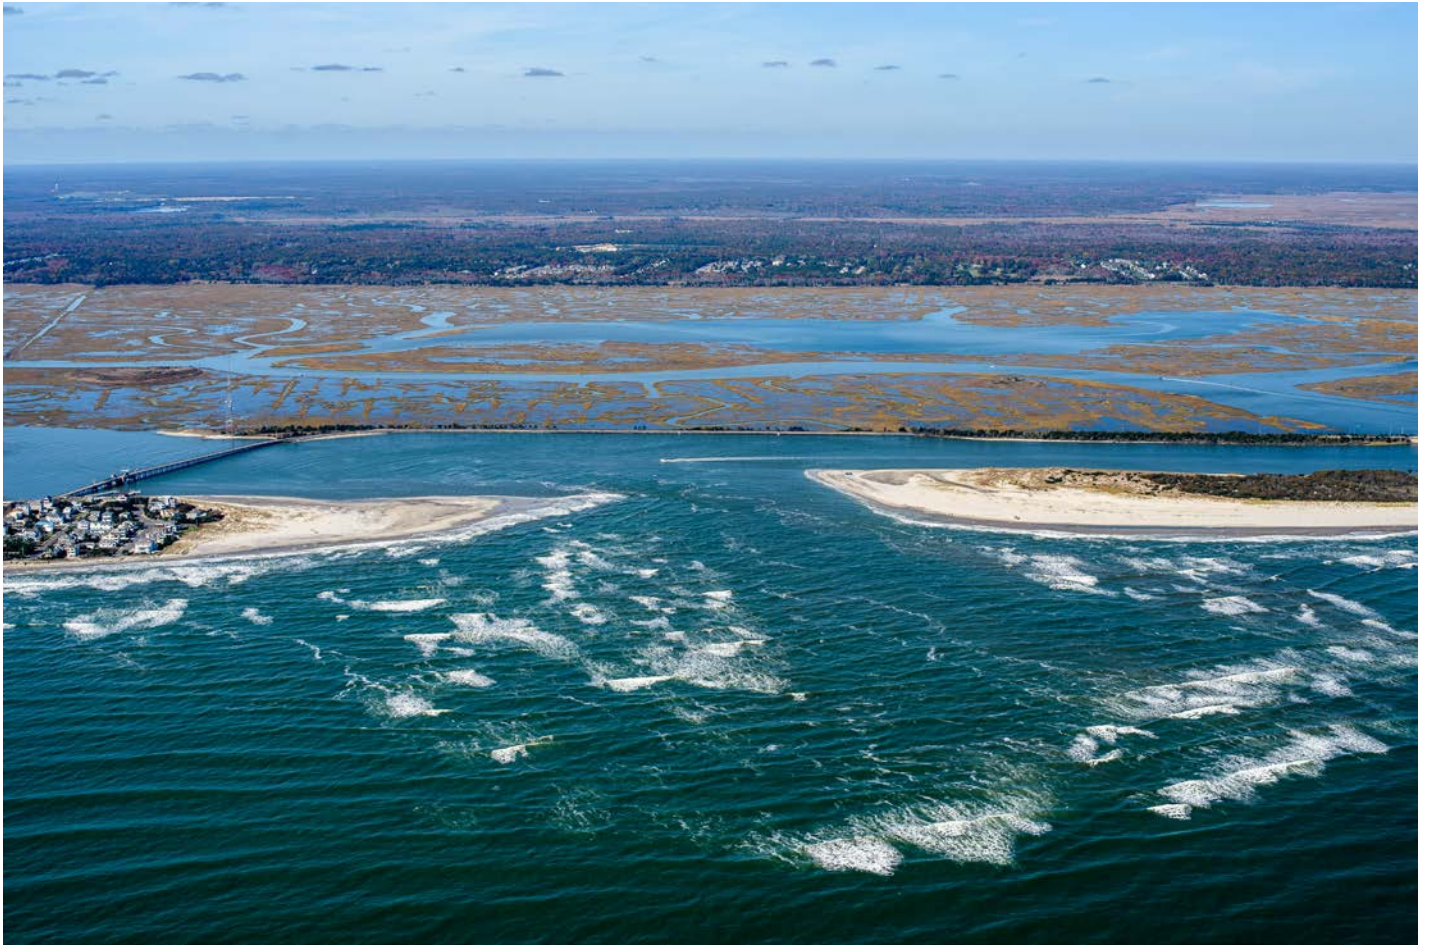
Figure 16. This October 30, 2022 photograph of Corson's Inlet shows the constriction of the main tidal channel by the surrounding ebb-tidal shoal system. Notice the absence of a clear navigable pathway out between Ocean City and northern Ludlam Island to the oceanfront. *(Photo by Ted Kingston)*

Inlet tidal dynamics continue to play a significant role in shoreline stability in the vicinity of Corson's Inlet and extensively shape the shoreline location. This is attributed to the interplay of positions between the main tidal channel to the north and an ephemeral secondary channel that periodically appears adjacent to the low tide line along the beaches proximal to Corson's Inlet in Upper Township. Historically, this formation of a secondary tidal channel running closer to the Strathmere shoreline acts as a scouring agent at the base of the beach effectively removing large volumes of sand at the very northeastern most point of the barrier island, and even in the absence of storm events can produce extensive shoreline retreat. As evident in Figure 16 below, the submerged shoal configuration has surrounded and restricted the main tidal channel, most likely forcing the inlet channel to swing south in response to the build-up of sand on the northern shoals, almost certainly resulting in the secondary tidal channel formation. Topographic and bathymetric surveys of the entire Corson's Inlet system would verify this premise.
