**DETERMINATION OF NEED REPORT**

**TOWN CENTER REDEVELOPMENT AREA**  
**BLOCK 599, LOTS 37, 51, 52, 56, 59, 60, 61, 62 & 63**

**TOWNSHIP OF UPPER**  
**CAPE MAY COUNTY, NEW JERSEY**

**June 17, 2026**

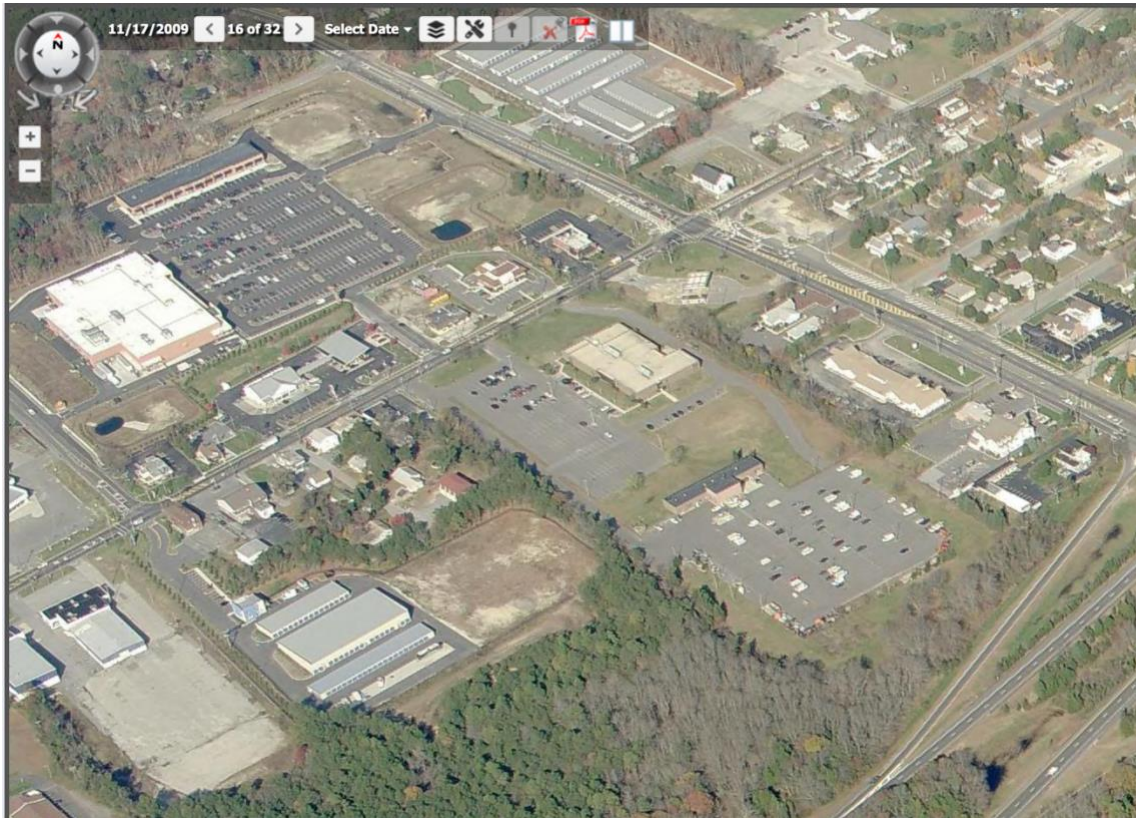
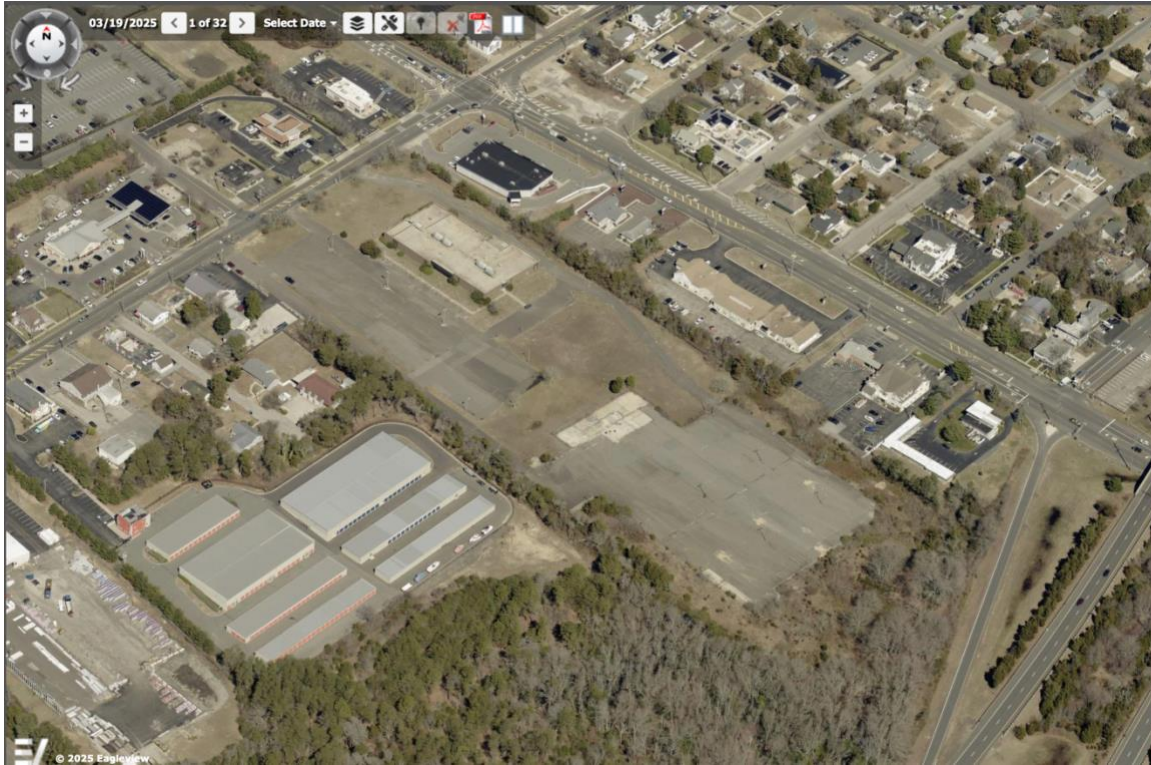
The principal building was constructed pursuant to permits issued in 1974. An addition was constructed onto the principal building for new office space to the front of the building pursuant to a 1988 site plan approval. The site remained occupied and utilized for telecommunications-related operations through the following decades. By 2019, the secondary building had been demolished, leaving the principal building and associated paved areas. The property is currently vacant. The following aerial views from Cape May

County Mapping show the site being partially utilized in 2009 and 2013 with subsequent dates in 2016 and 2025 showing the site vacant and unutilized.

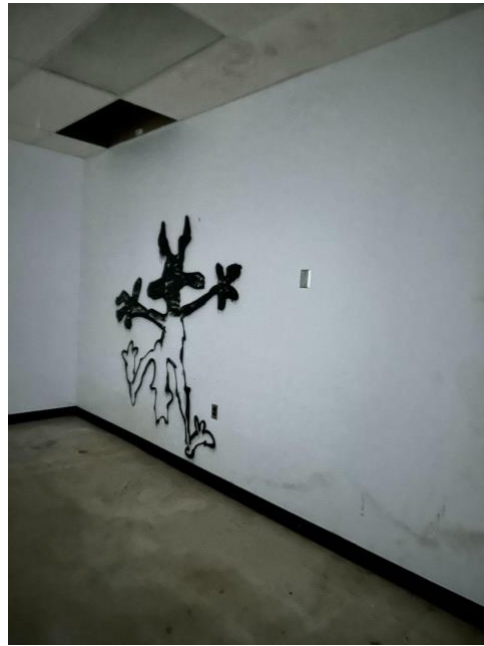
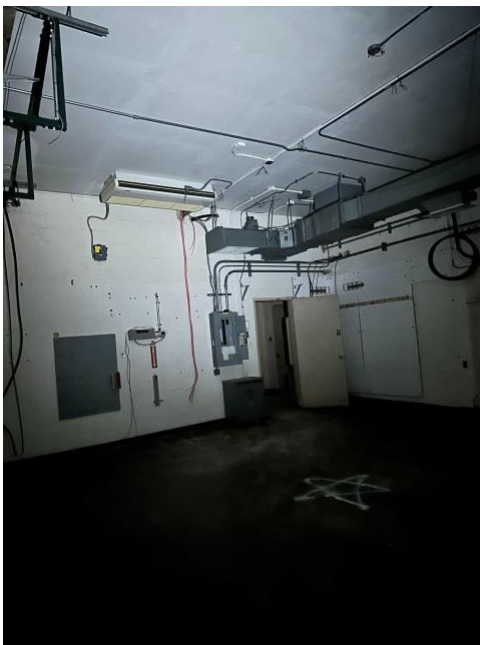
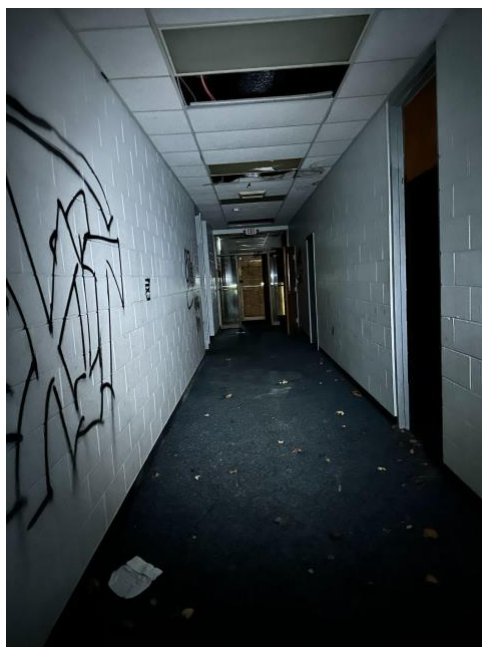
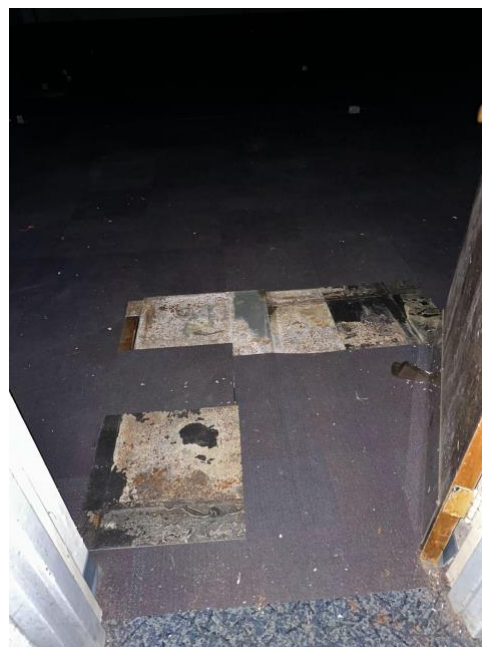
A site inspection, which included a walk-through of the building on May 6, 2026, showed visible deterioration of the building. The photographs below, taken on the same date of the walk-through, show the building is in poor condition. The large glass windows have been broken out and boarded up with plywood. The building has been vandalized. There is deterioration including water intrusion, damaged and missing ceiling finishes, deteriorated wall surfaces, and exposed building systems. The building has no active HVAC system and is musty and has areas of mold and/or mildew as shown in the photographs. Portions of the structure have been adversely impacted by prolonged vacancy and lack of maintenance and would require substantial rehabilitation before being returned to productive use.

Site inspection revealed conditions in remaining building associated with prolonged vacancy and deferred maintenance including water intrusion, damaged and missing ceiling systems, deteriorated interior finishes, exposed building infrastructure, vandalism, evidence of unauthorized entry, and extensive areas of vacant office space. The property also contains obsolete utility infrastructure associated with its former telecommunications use, including former fuel storage and dispensing facilities, septic systems, environmental monitoring wells, and related site improvements.

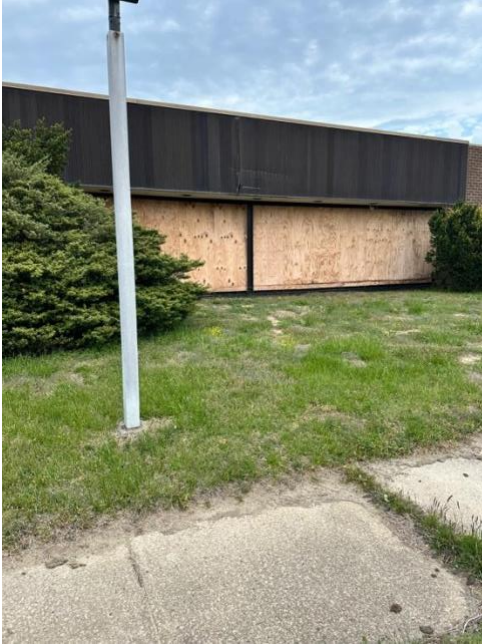
*Boarded up / Broken Windows*

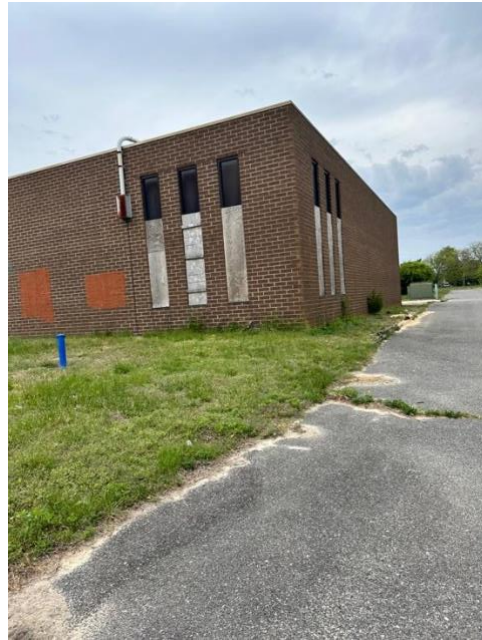
*Boarded up Broken Windows*

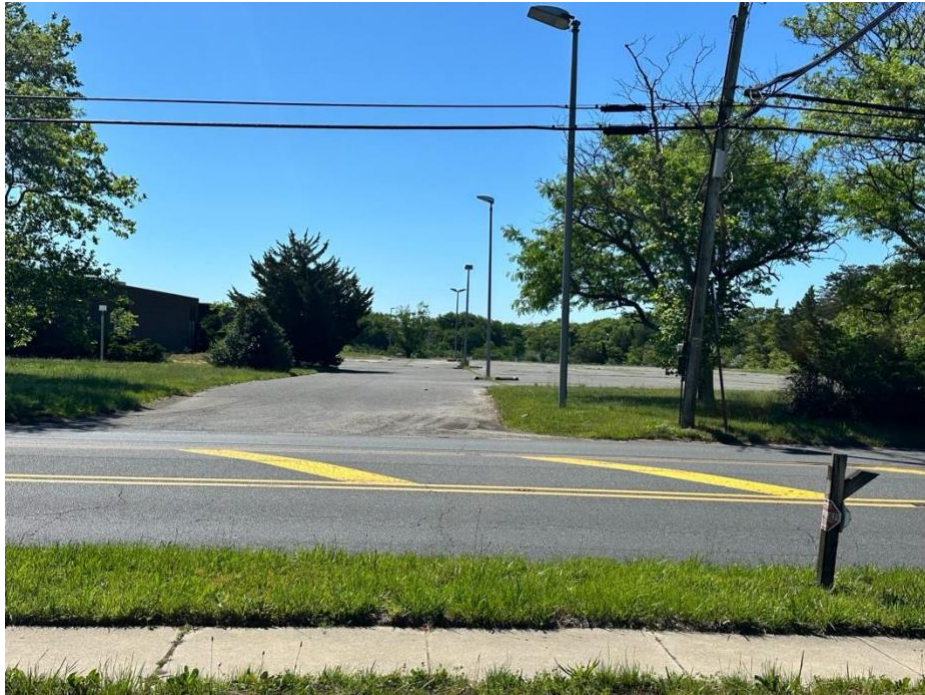
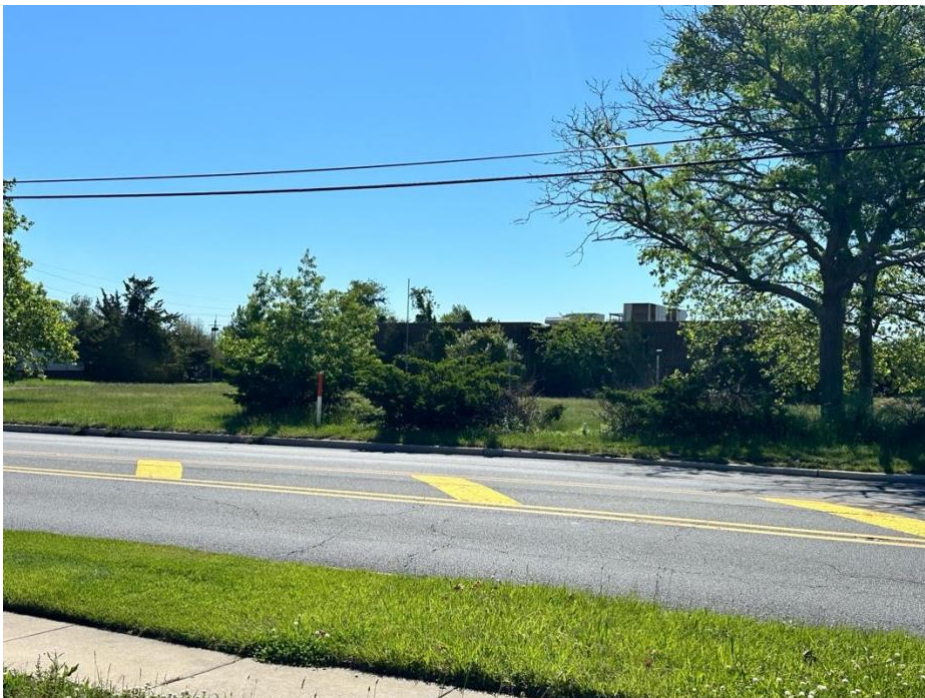
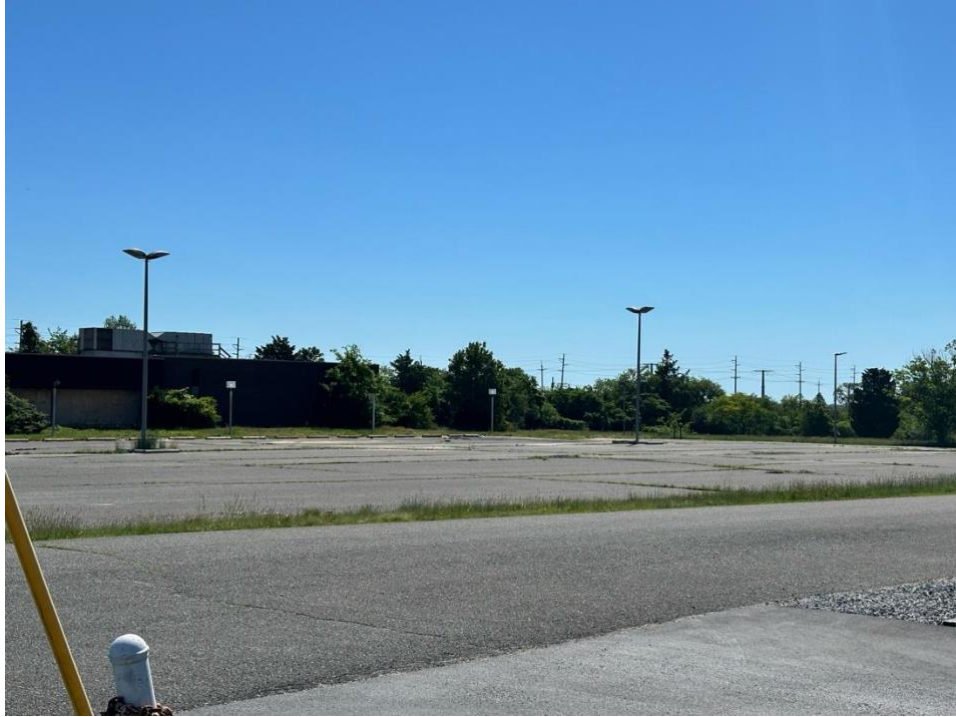
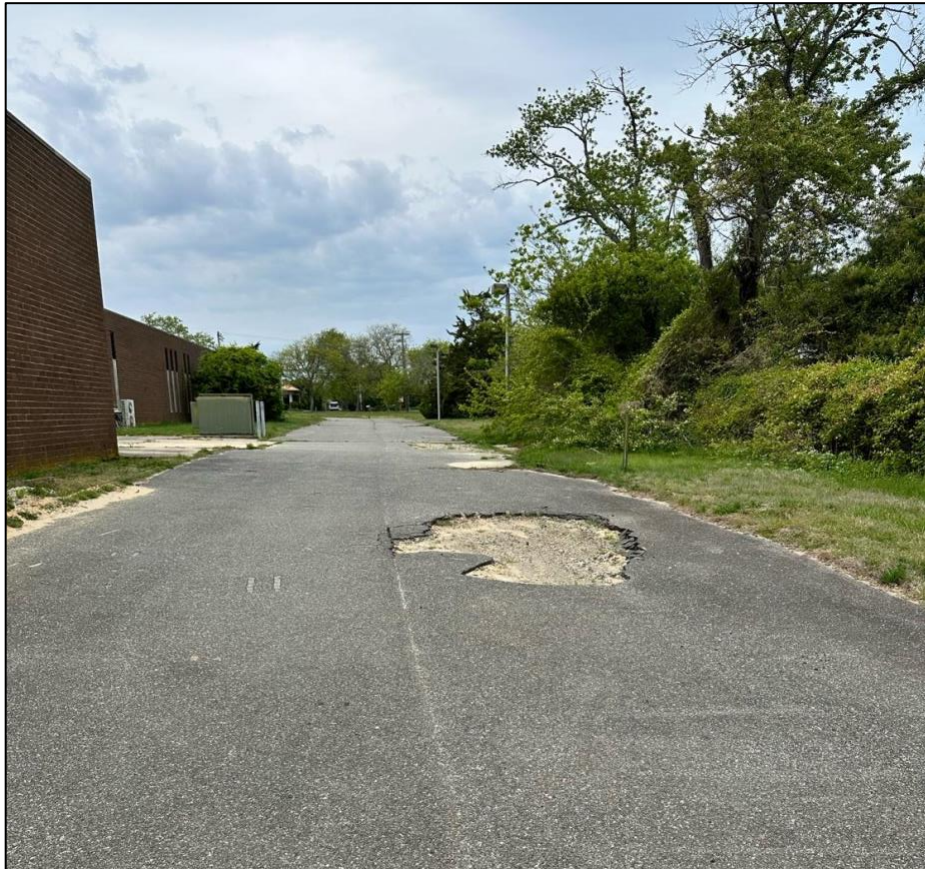
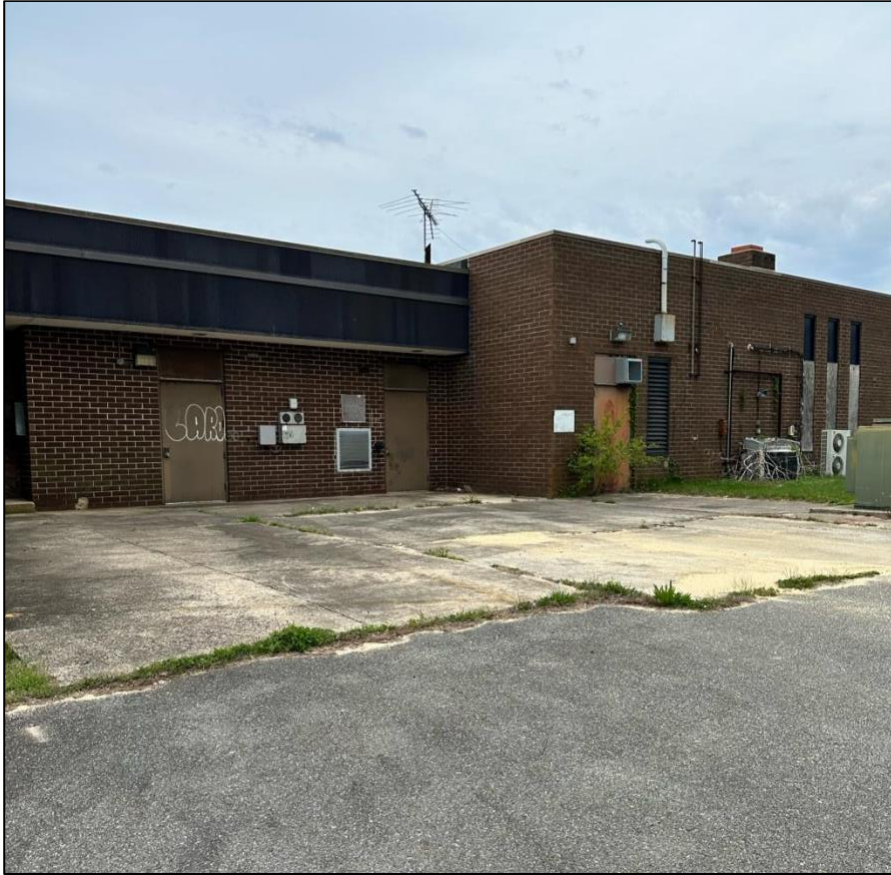
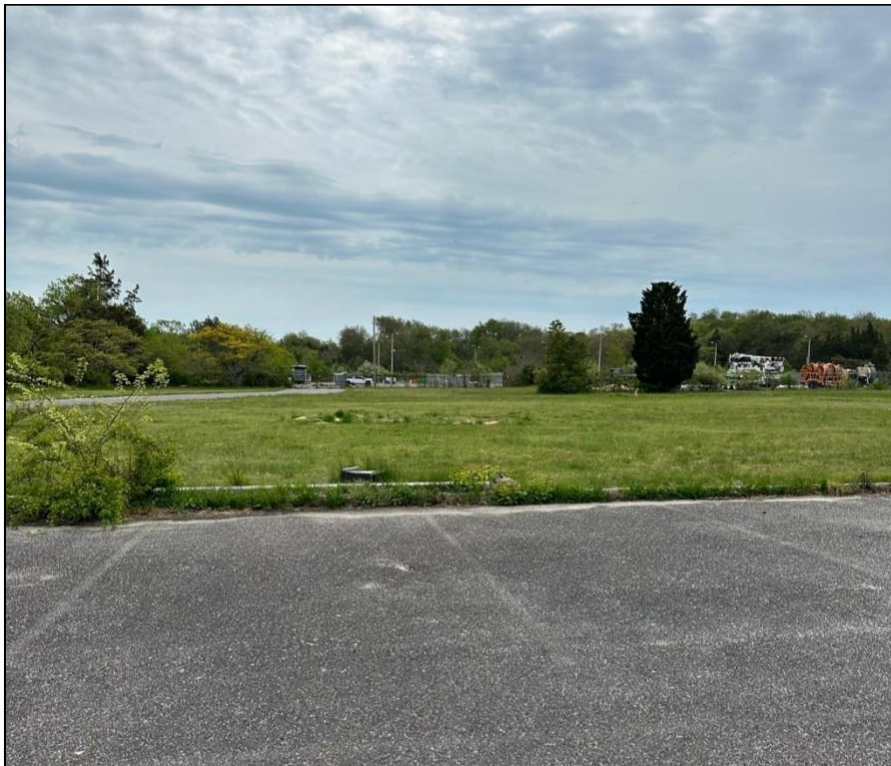
Photographs of Existing Site Conditions:

The property contains large open parking areas with broken asphalt and overgrown vegetation. Shown in the following photos are existing site conditions. The large expanse of open asphalt areas is obsolete and represent excessive land coverage which is not useful and has limited reuse opportunities. The temporary use by Atlantic City Electric for storage of construction materials has been the only interim use and is shown to utilize the rear of the site in the last photograph. These operations have completed or are at the end of use.

The combination of prolonged vacancy, building deterioration, obsolete infrastructure, environmental constraints, and underutilization limit the productive use of the property and creates physical and economic impediments to redevelopment. These conditions contribute to the obsolescence of the Site.
