**DETERMINATION OF NEED REPORT  
BEESLEY'S POINT STUDY AREA**

**TOWNSHIP OF UPPER  
CAPE MAY COUNTY, NEW JERSEY**

**September 2020**

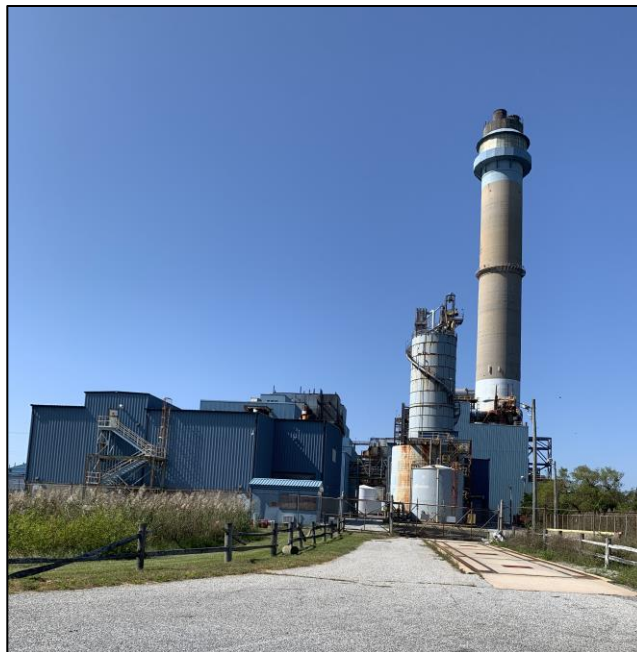
**Figure 1 – Air Scrubbers and Buildings**

Figure 1 shows the larger building and air scrubbers. The plant operations required various elements to enable the conversion of coal and oil to electric.

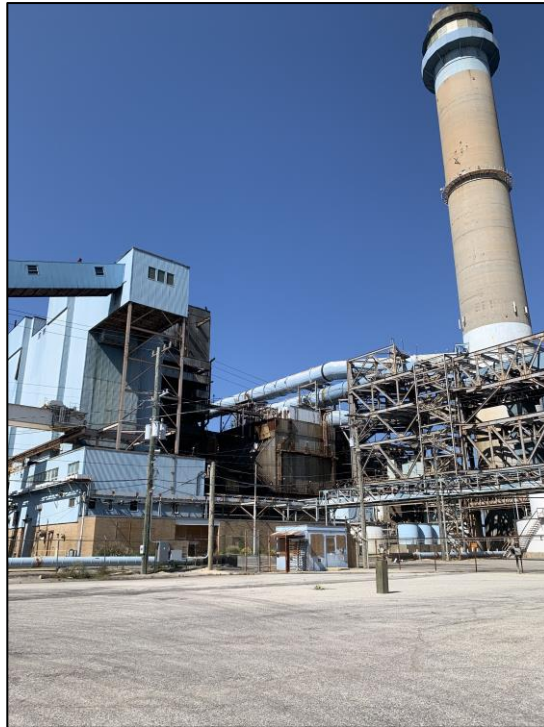
**Figure 2 – Air Scrubber, buildings and improvements**

Figure 2 shows the air scrubber and pipes as well as a closer look at the various elements/structures needed to operate the plant.

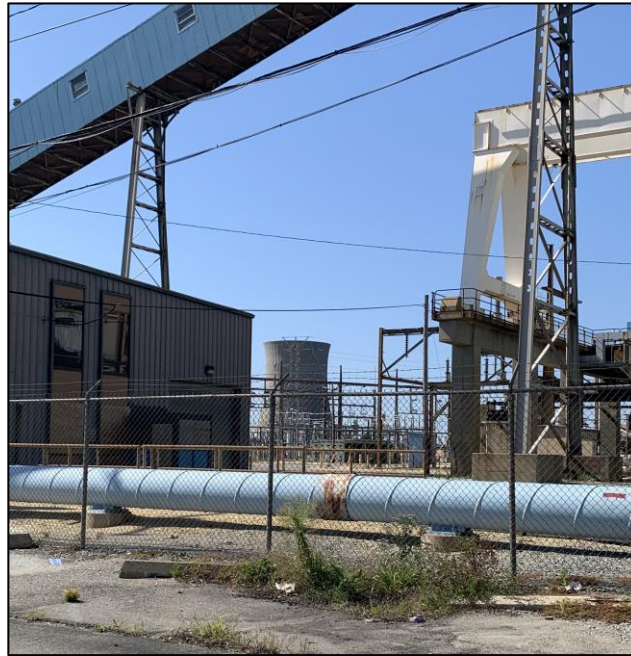
**Figure 4 – Cooling Tower, Electrical Substation and improvements**

Within Figure 4 is the electrical substation, located in the center of the site, will be required to remain and be incorporated into any future redevelopment of the property. This substation area will consist of about an acre of land from the total 300+ acres of the site. The substation is surrounded by various improvements and structures which will require removal from the property.

The reuse of the structures comprising the B.L. England Plant is extremely limited. Removal of the structures and improvements would be an extensive and costly undertaking. The plant has operated for over 60 years. This long-term use as a coal powered and oil powered electrical generating system, has resulted in land and water contamination which must be remediated before any new use of the property can be made.

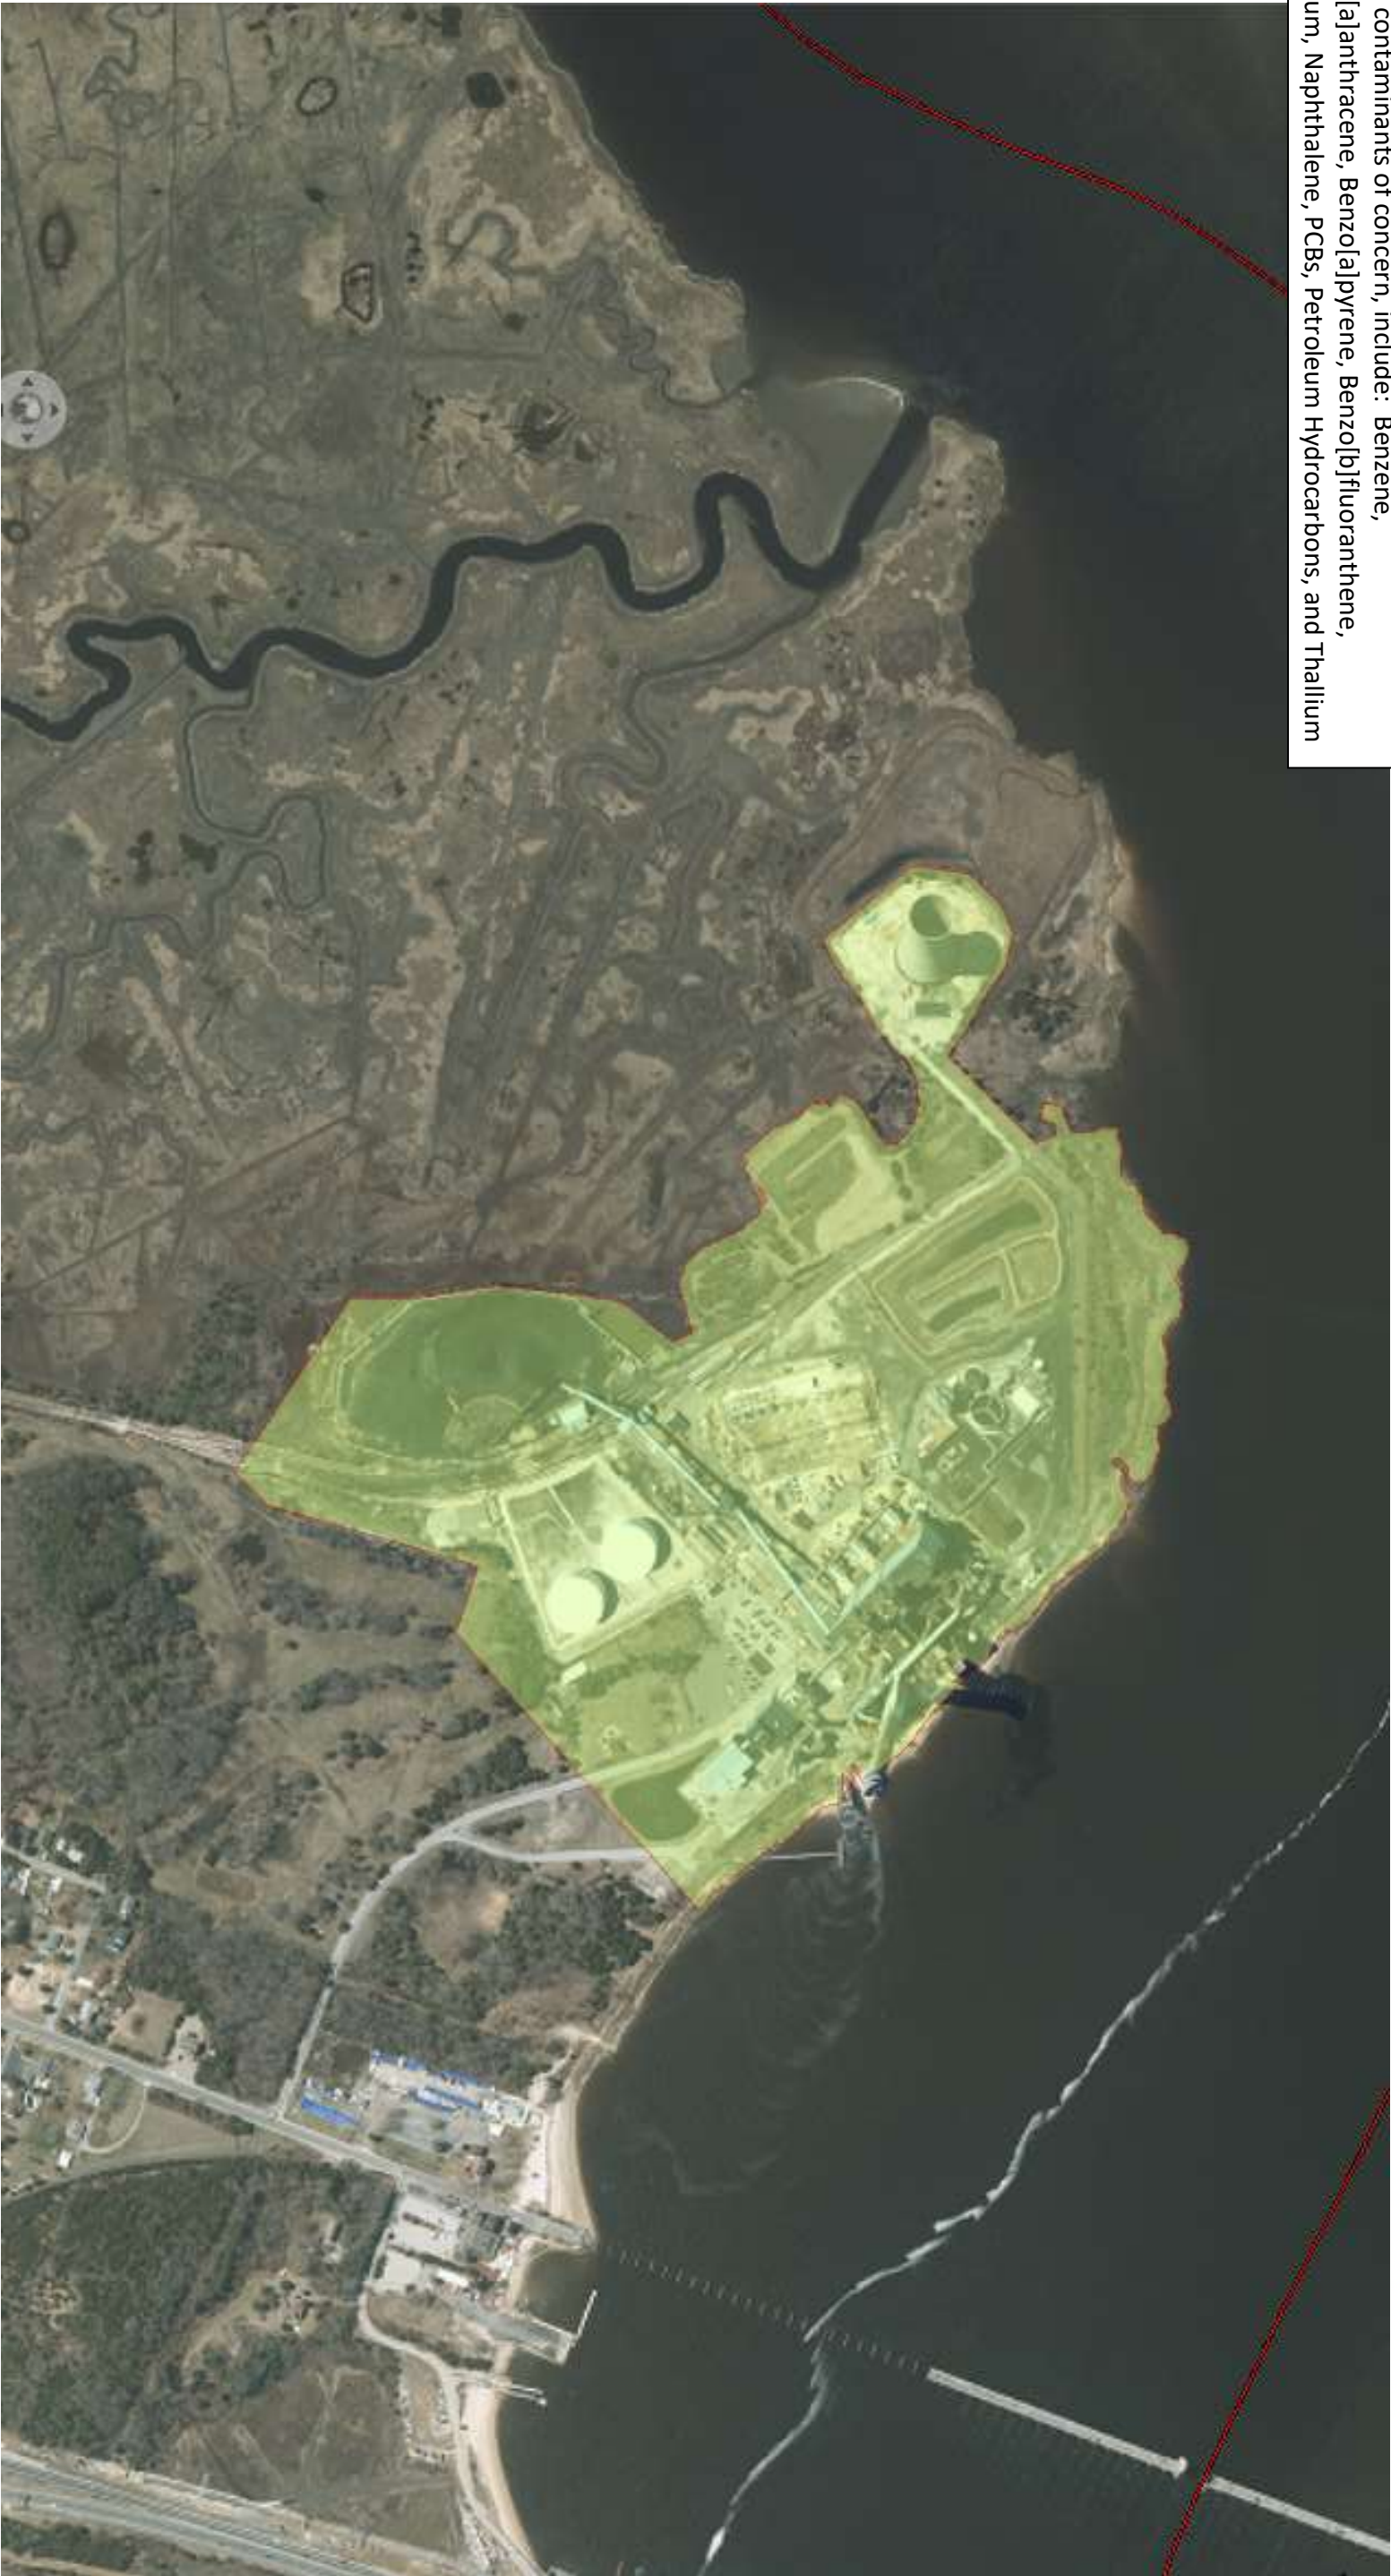
Noted contaminants of concern, include: Benzene, Benzo[a]anthracene, Benzo[a]pyrene, Benzo[b]fluoranthene, Beryllium, Naphthalene, PCBs, Petroleum Hydrocarbons, and Thallium

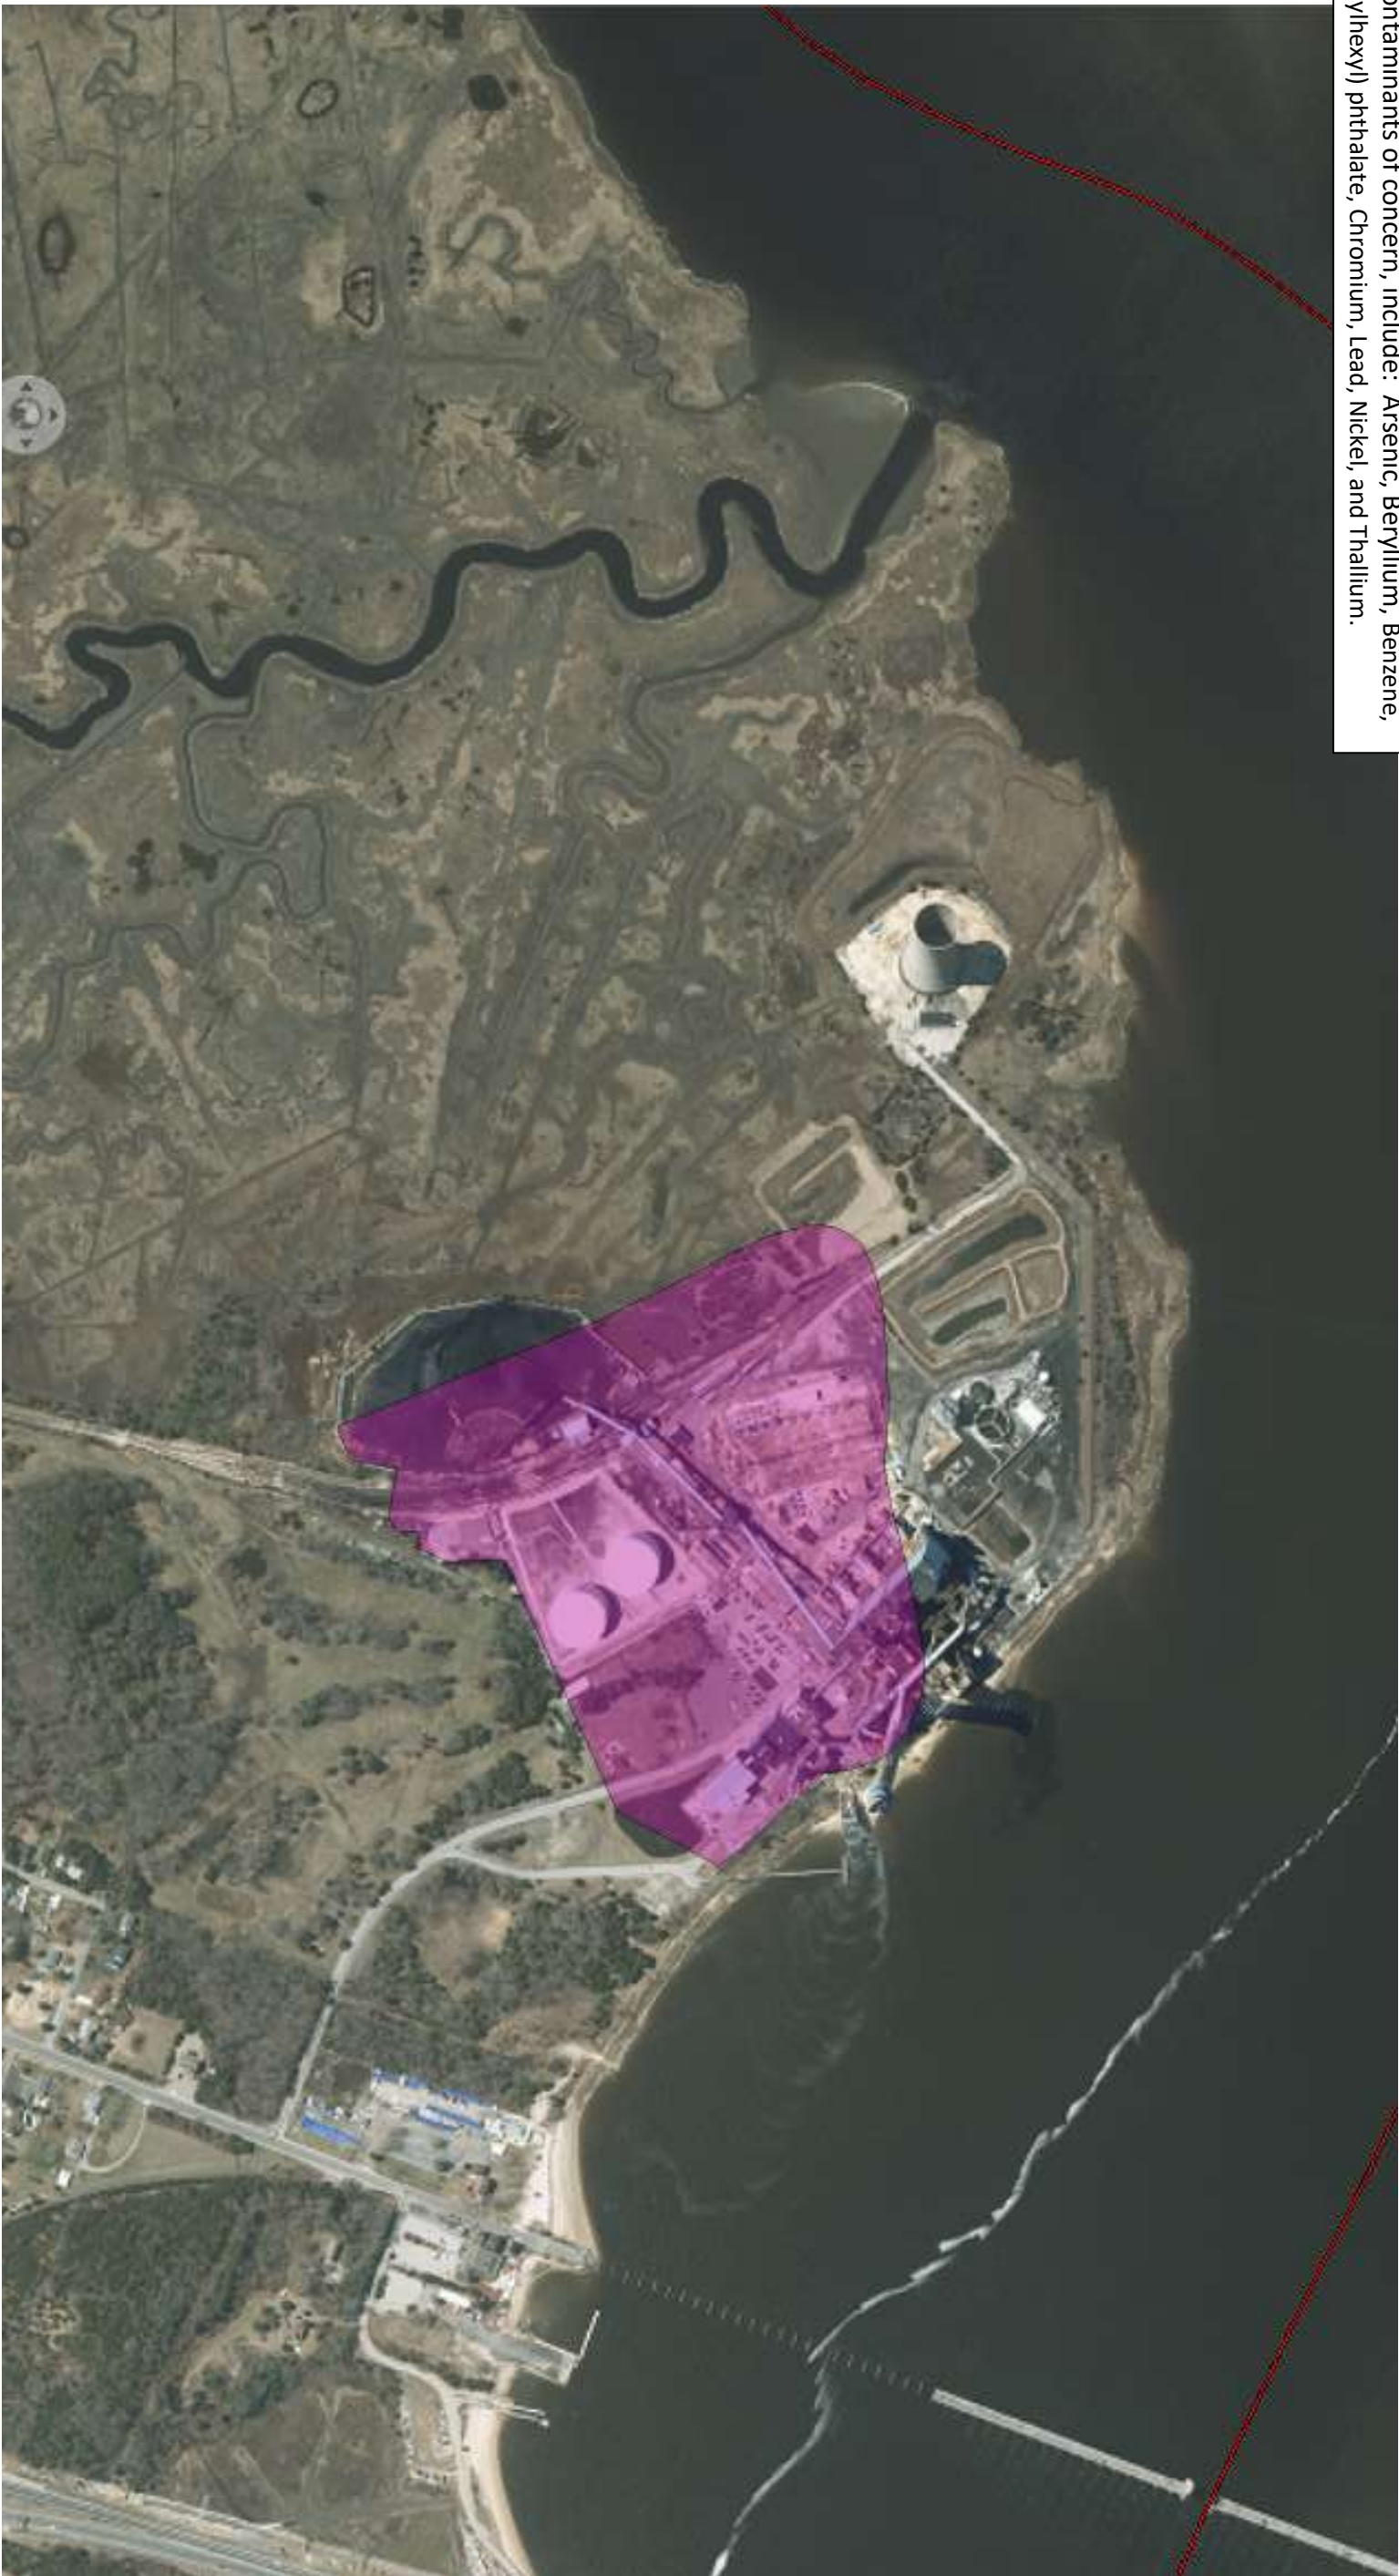
Noted contaminants of concern, include: Arsenic, Beryllium, Benzene, Bis (2-ethylhexyl) phthalate, Chromium, Lead, Nickel, and Thallium.
